# the **play inspection** company

## Annual Inspection

Mid Suffolk District Council

Creeting St Peter

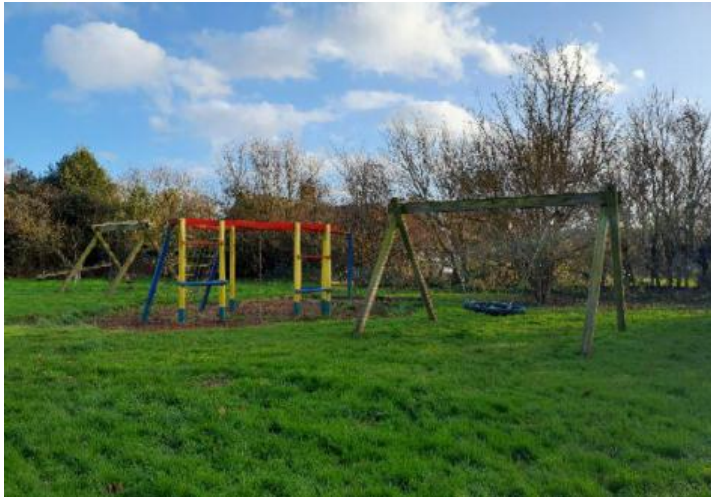
**Finding:** It is recommended that signage, with information including the site address, contact information for maintenance issues and emergency contact details are provided for the facility

**Action:** Provide in accordance with the recommendations

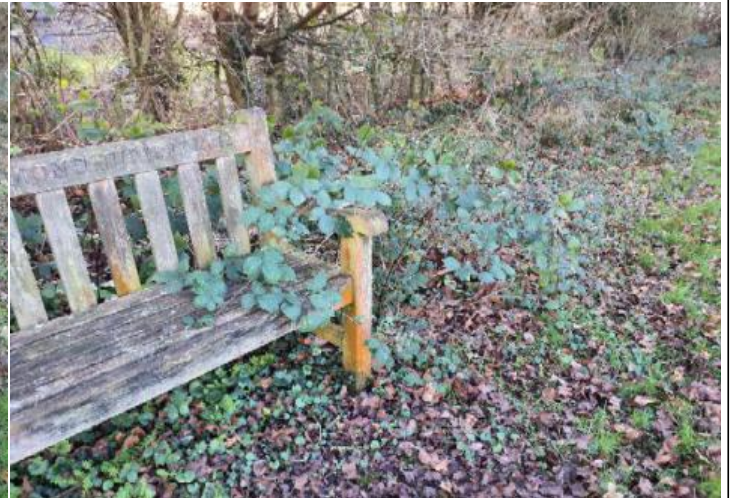
**Finding:** The adjacent foliage is overhanging

**Action:** Cut back and maintain

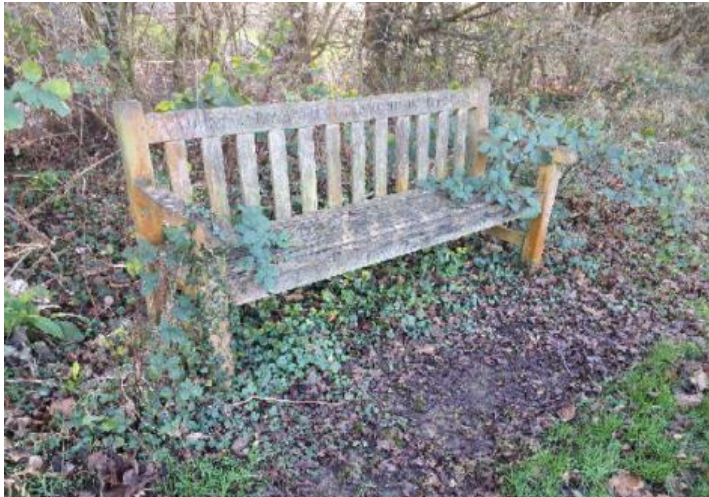
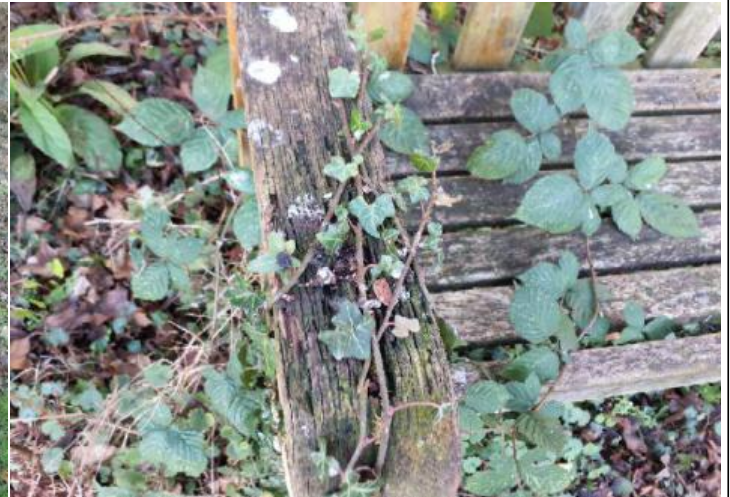
**Finding:** There is some evidence of rot in the timber

**Action:** Monitor for any further deterioration and replace as required

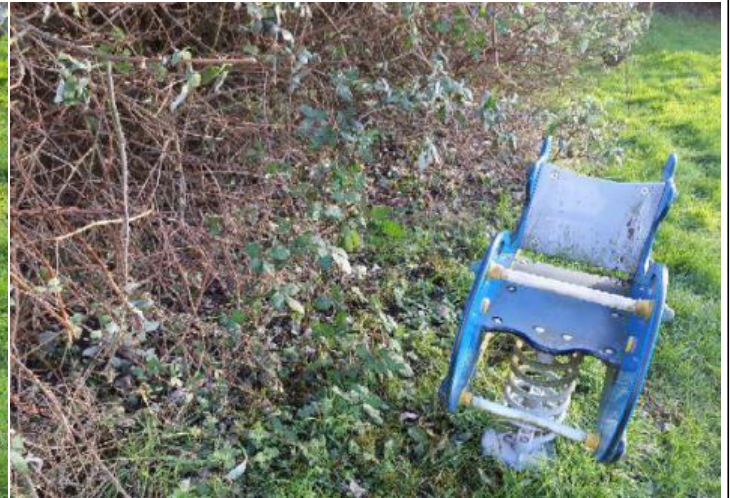
**Finding:** The adjacent hedge forms a hard object within the falling space of the equipment in contravention of the requirements of BS EN 1176 Part 1  
**Action:** Cut back and maintain 1000mm falling space

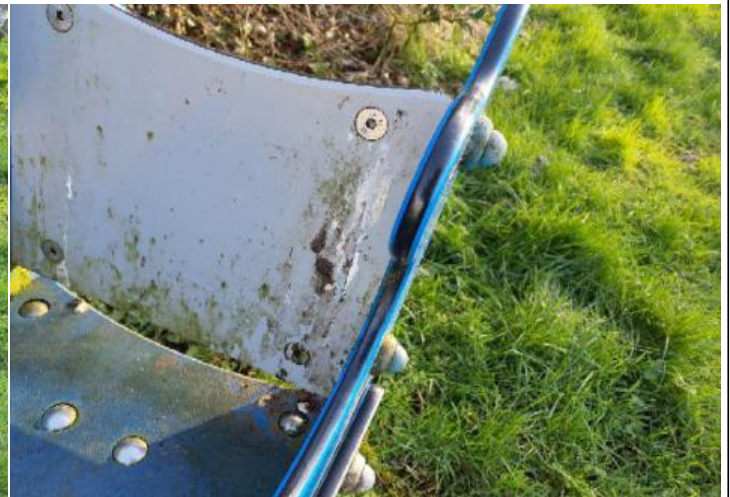
**Finding:** There is excrement on the equipment  
**Action:** Clean and maintain

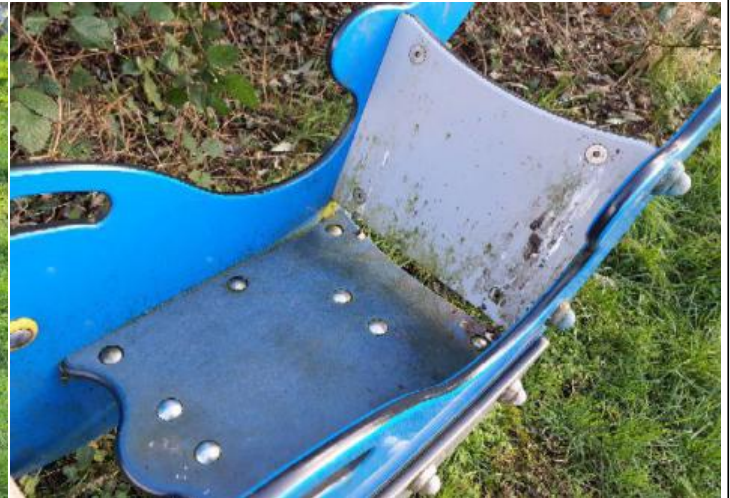
**Finding:** There is algae or moss on the surface of the equipment

**Action:** Clean and treat appropriately

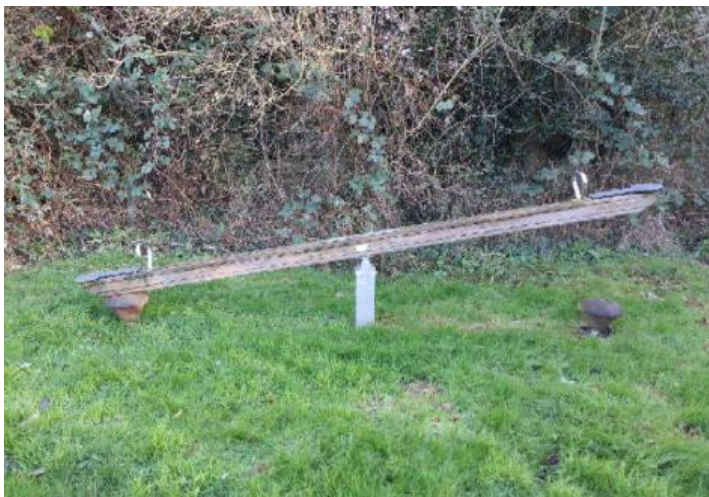
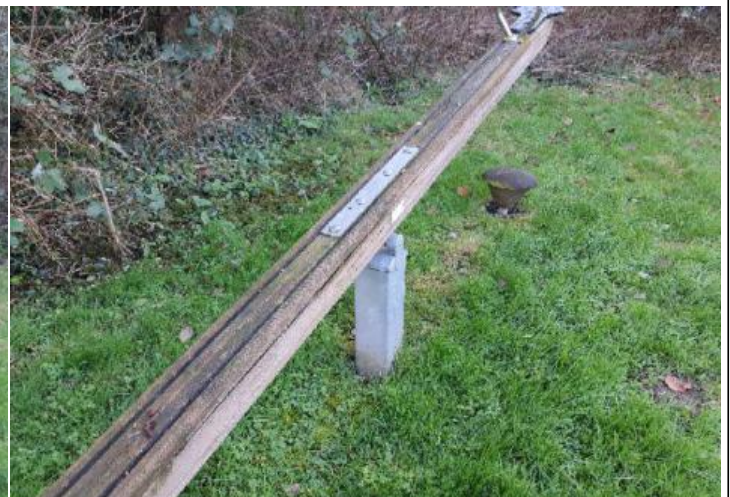
**Finding:** There is minor lateral movement of the beam

**Action:** Monitor for any further deterioration and repair or replace as required

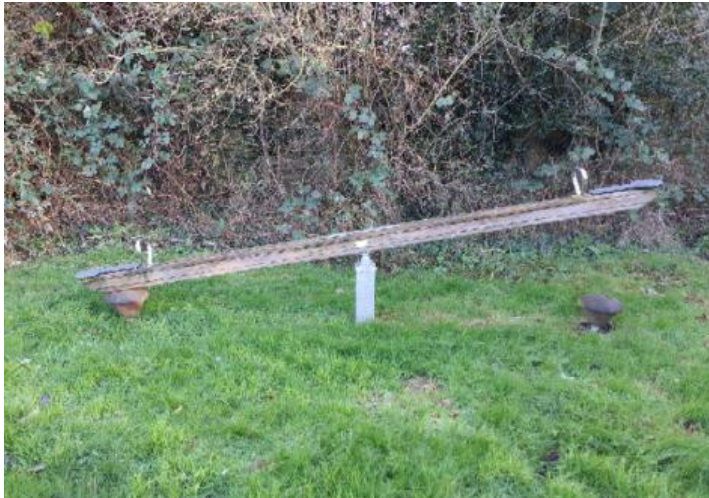
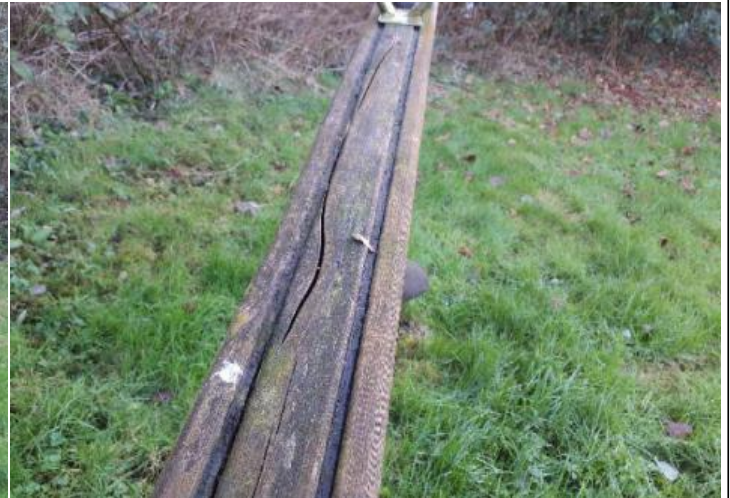
**Finding:** The timber has a number of splits/shakes or air cracks and this may affect the stability or allow water ingress which will accelerate the rotting process  
**Action:** Monitor to ensure the splits do not cross through fixing points of the structure and/or cause any instability

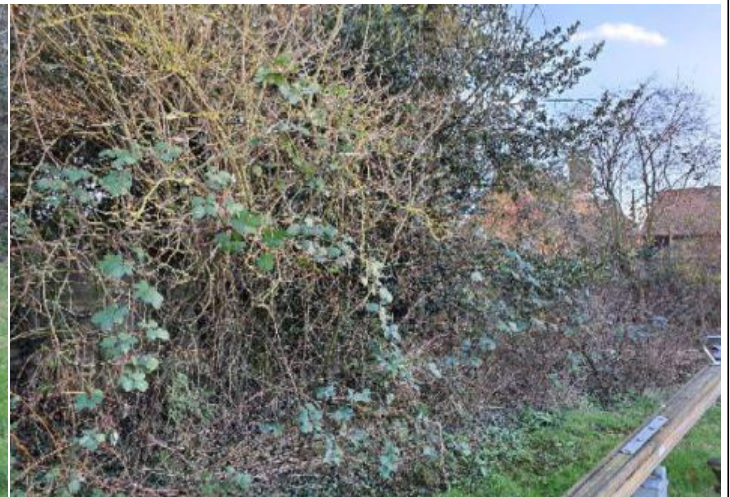
**Finding:** The tree canopy overhangs the equipment and is less than 2.0m away  
**Action:** Lift tree canopy to ensure a minimum clearance of 2.0m from the equipment

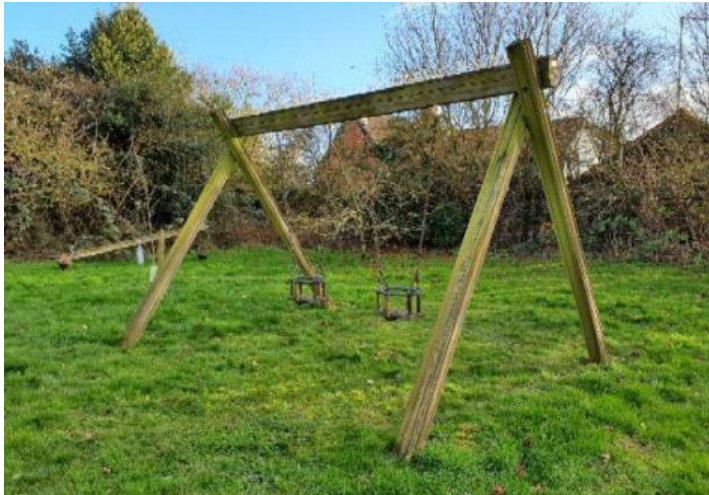
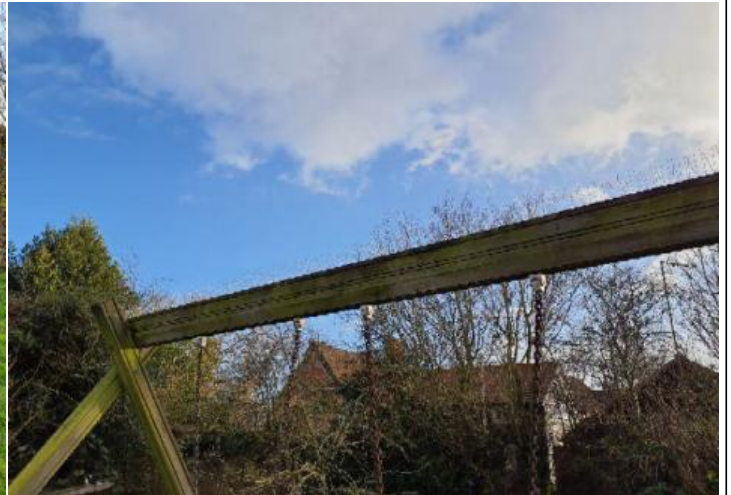
**Finding:** We do not recommend the installation of anti bird devices on equipment

**Action:** Remove and replace with upturned cable ties

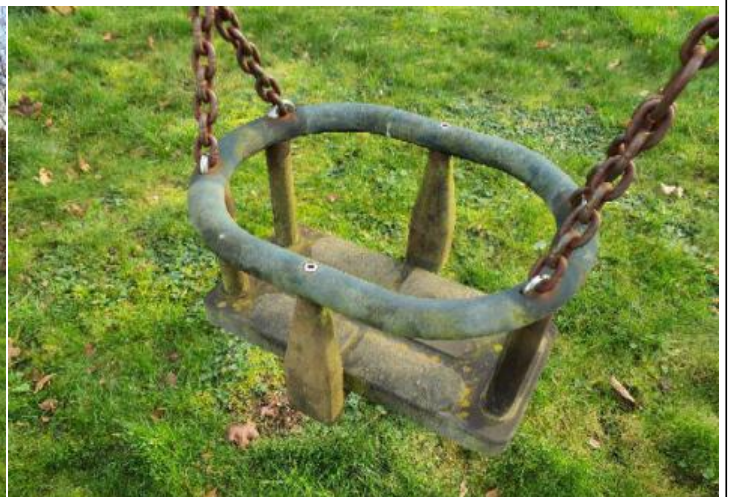
**Finding:** There is algae or moss on the surface of the equipment

**Action:** Clean and treat appropriately

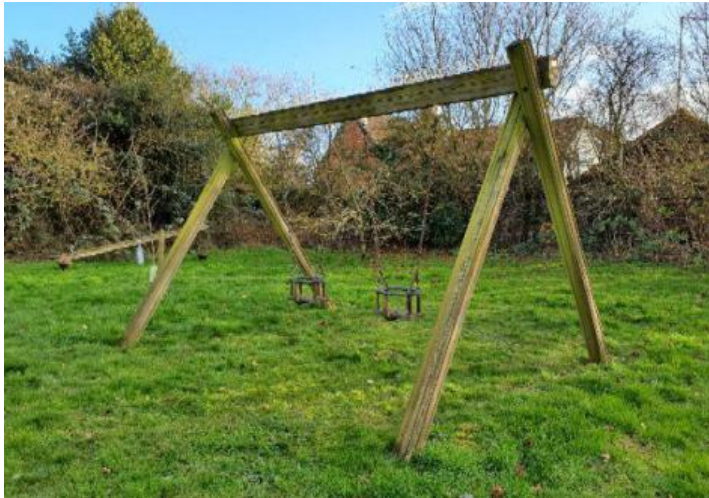
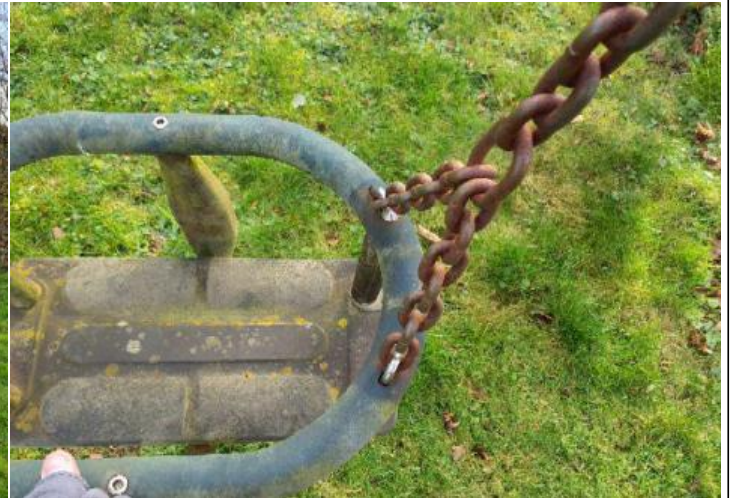
**Finding:** The chains are rusting

**Action:** Monitor for any further deterioration and replace as required

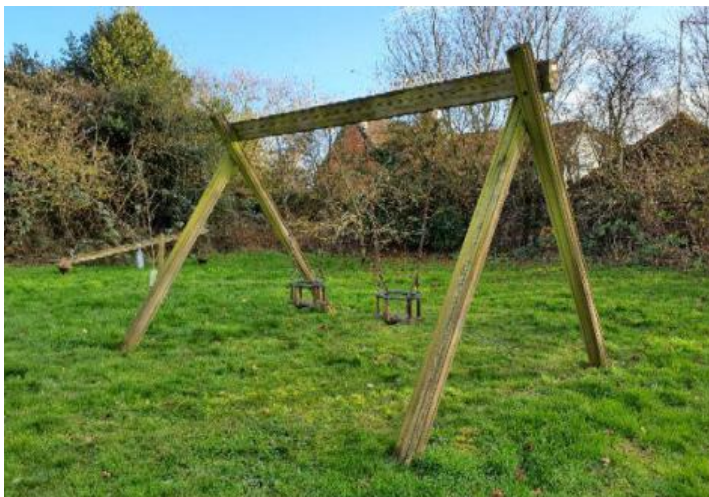
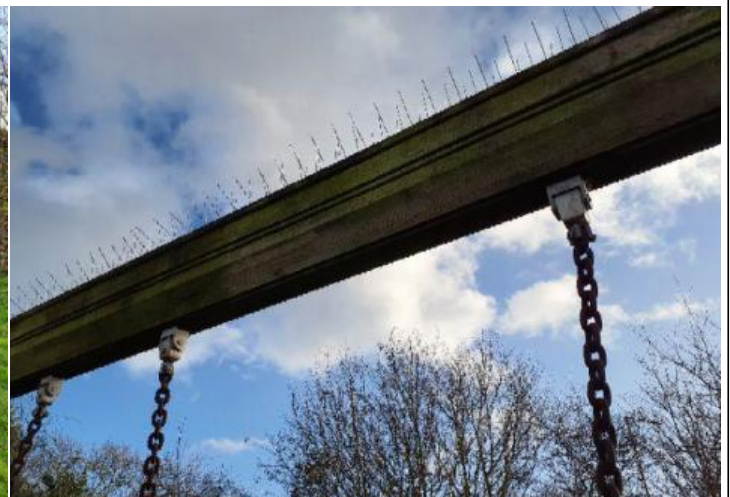
**Finding:** This design of swing joint has been known to fail on the weld connecting the joint to the threaded stud

**Action:** We would recommend that the joint be dismantled and checked on a regular basis or consulting with manufacturer on whether a Secondary Safety Device can be fitted

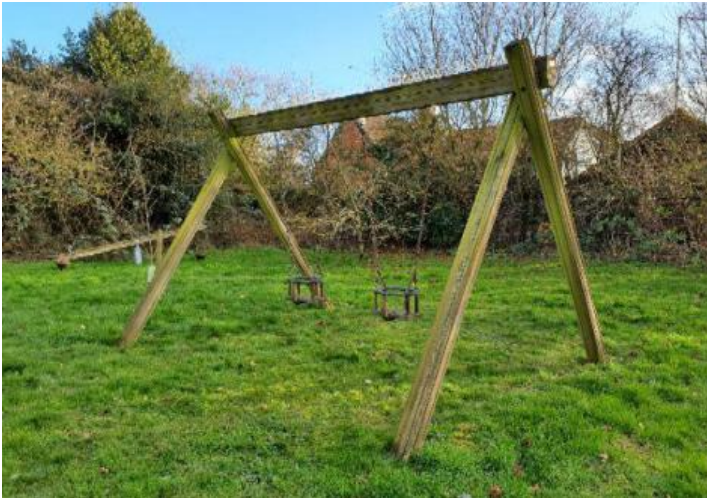
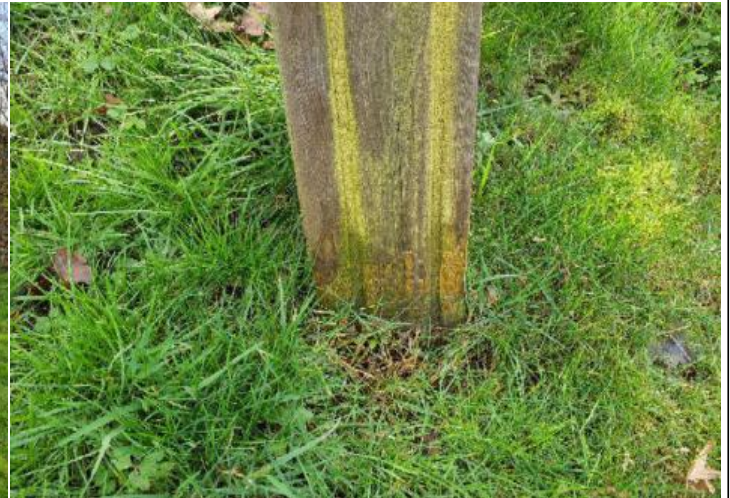
**Finding:** There is some strimmer / machinery damage apparent on the posts, this can penetrate the preservative applied to the timber and accelerate the rotting process

**Action:** Monitor for any deterioration (rot) and replace as required

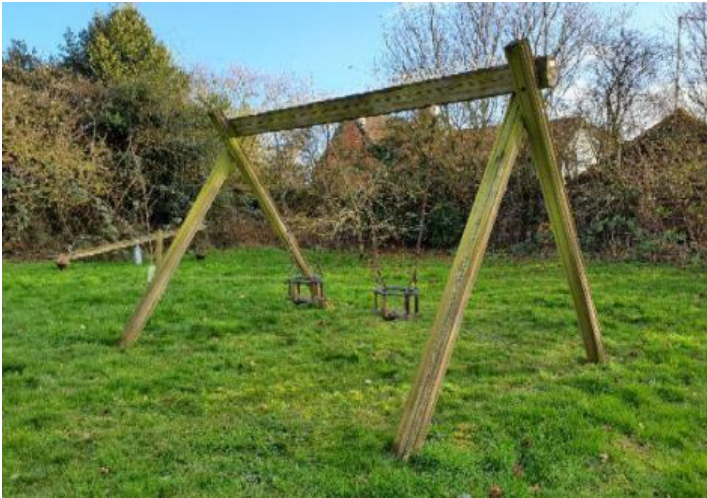
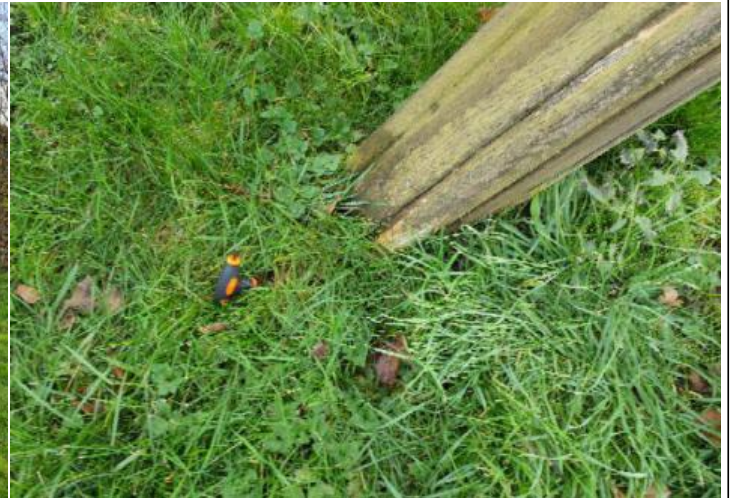
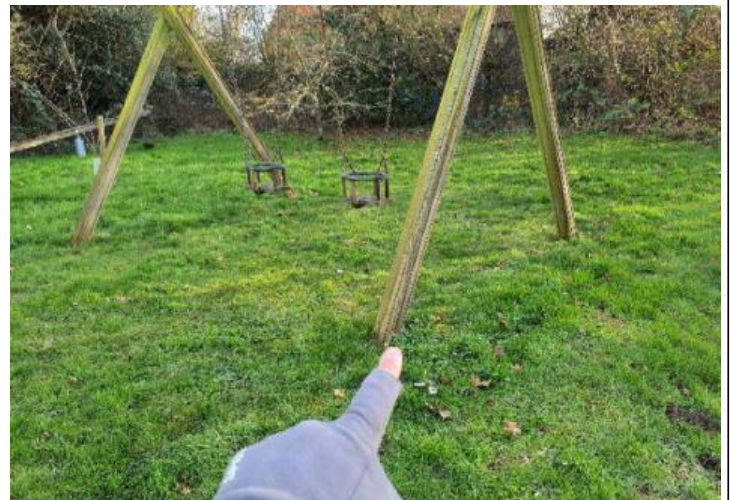
**Finding:** There is some evidence of rot in the timber

**Action:** Monitor for any further deterioration and replace as required

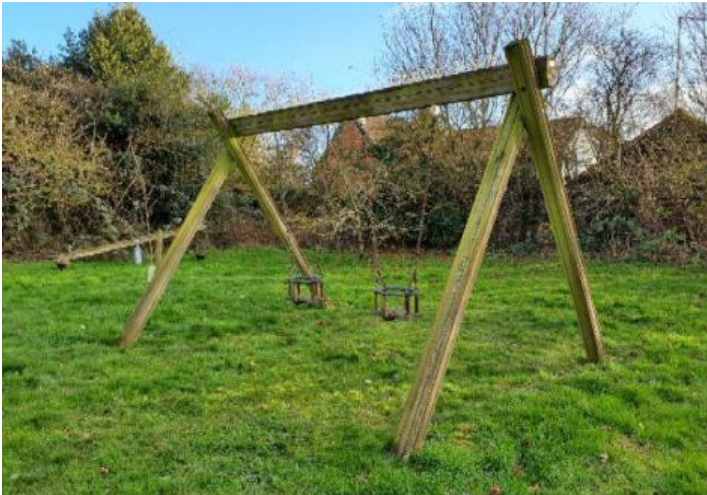
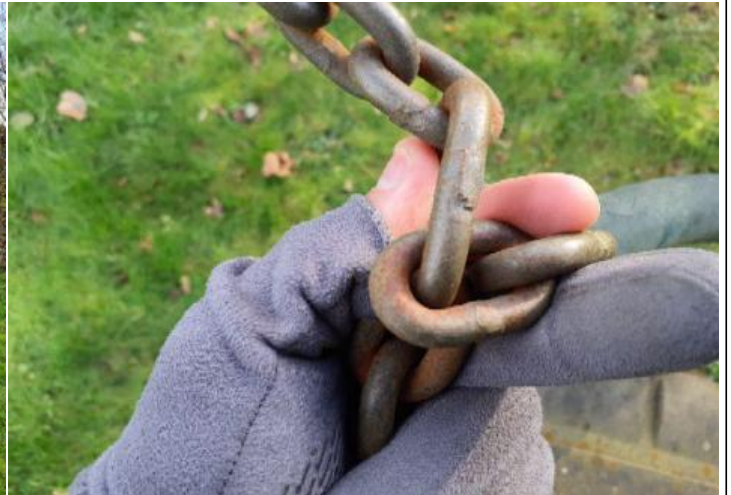
**Finding:** There is some notable evidence of chain wear

**Action:** Monitor for any further deterioration and replace when 40% worn

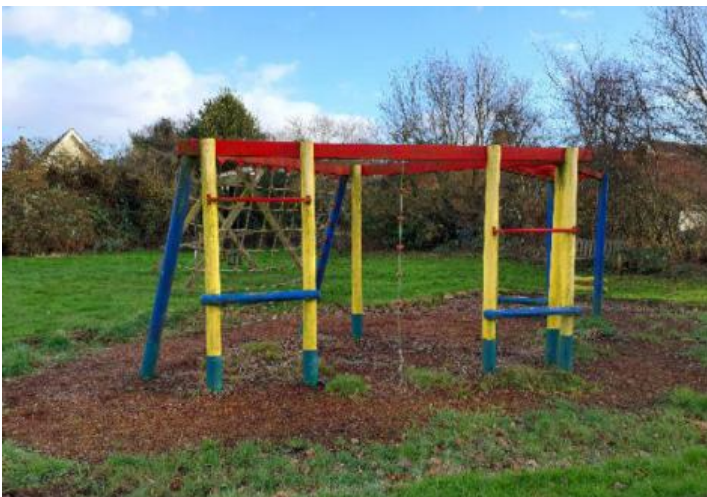
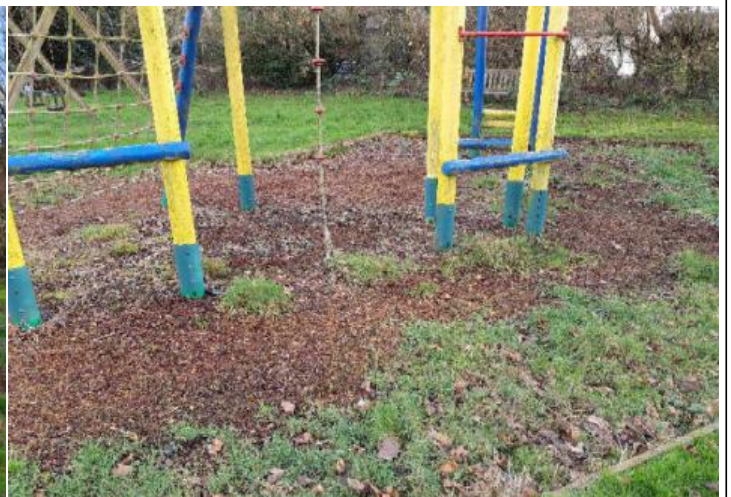
The depth of the loose fill surfacing is lower than the recommended depth specified in BS EN 1176; the free height of fall of the equipment is less than 2.0m and a minimum of 300mm depth should be provided (including an extra 100mm to allow for compaction and displacement as per BS EN 1176 Part 1 - Table 4) - Top up loose fill surfacing to recommended levels

**Finding:** The depth of the loose fill surfacing is lower than the recommended depth specified in BS EN 1176; the free height of fall of the equipment is less than 2.0m and a minimum of 300mm depth should be provided (including an extra 100mm to allow for compaction and displacement as per BS EN 1176 Part 1 - Table 4)

**Action:** Top up loose fill surfacing to recommended levels

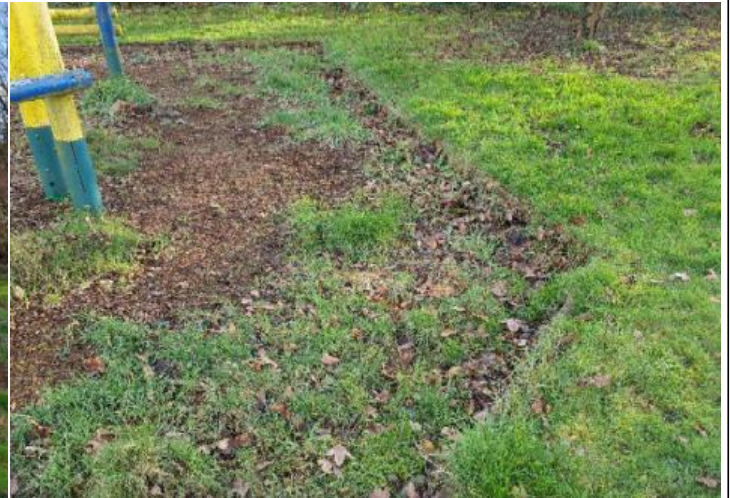
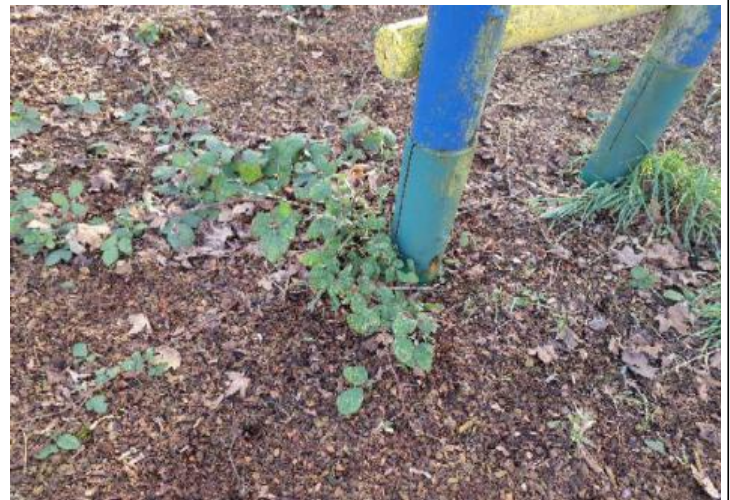
**Finding:** There is weed / vegetation growth on, between, or around the edges of the surfacing **Action:** Remove weed / vegetation growth

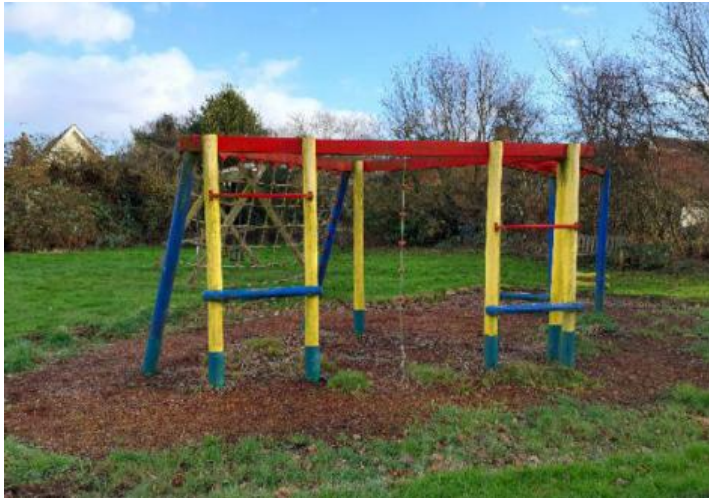
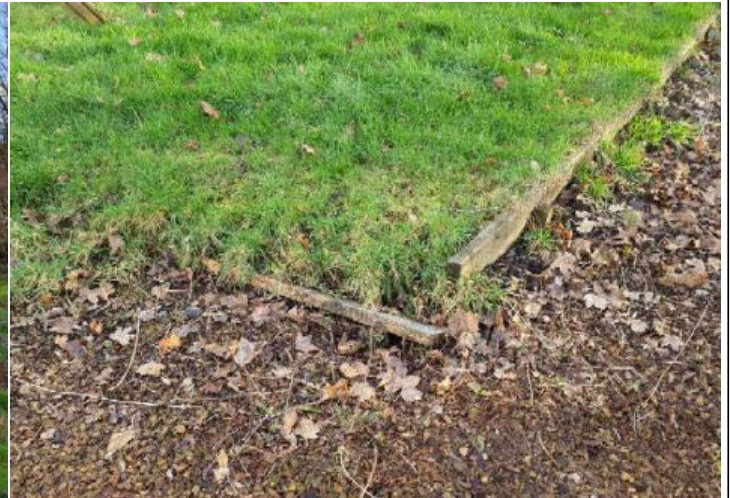
**Finding:** There are areas or parts of the timber edging that have rotted or are damaged

**Action:** Replace all affected timbers

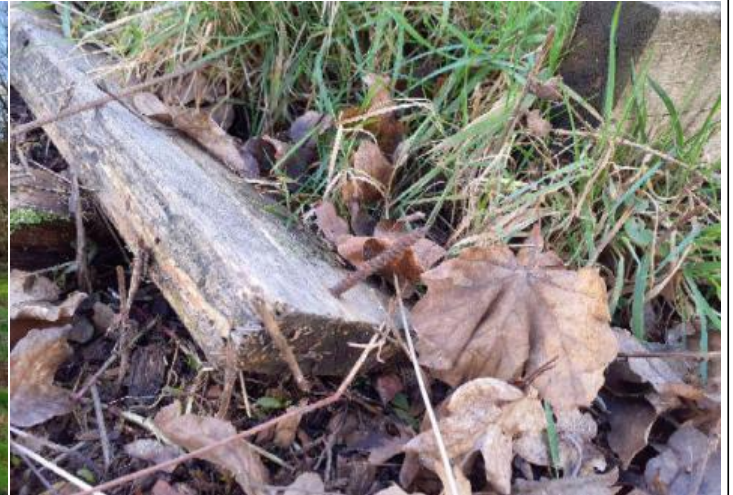
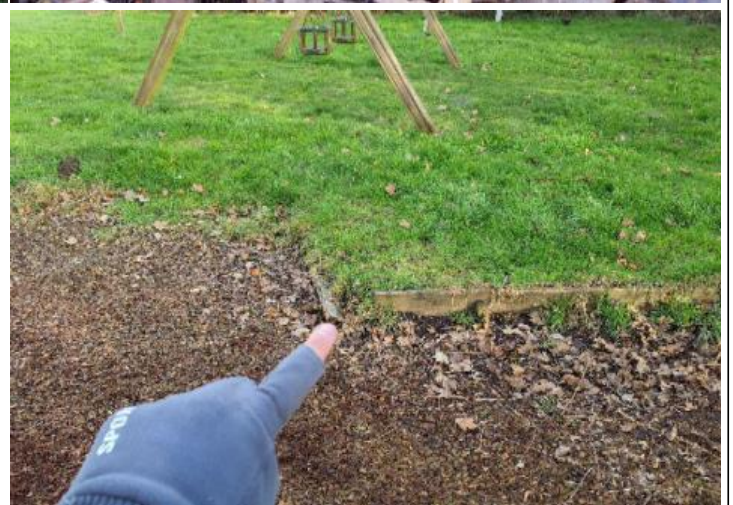
**Finding:** There are projecting nail ends present

**Action:** Remove and provide more appropriate fixings if required

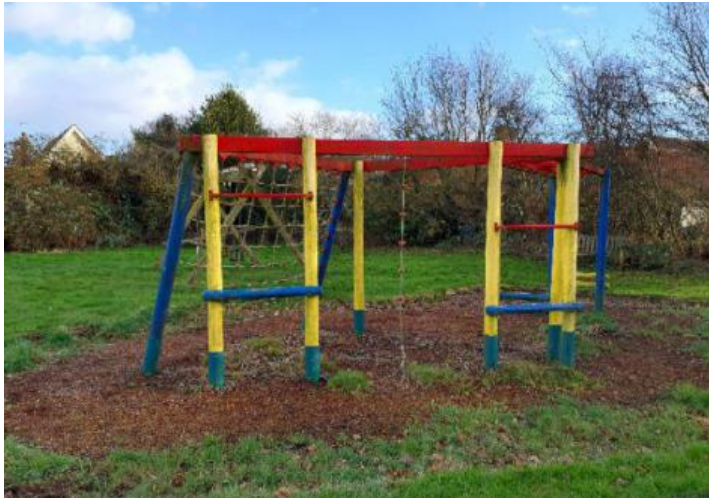
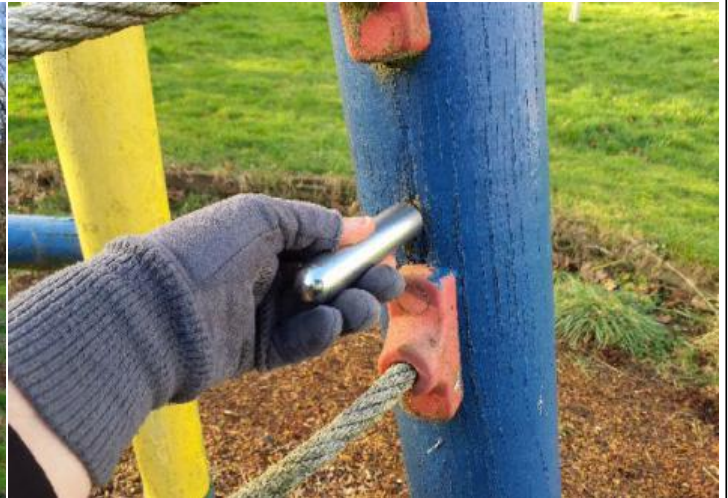
**Finding:** There is/are finger entrapment/s in the post due to missing inserts and the item fails to meet the requirements of BS EN 1176 Part 1 4.2.7.6 Entrapment of fingers  
**Action:** Provide inserts to remove entrapment

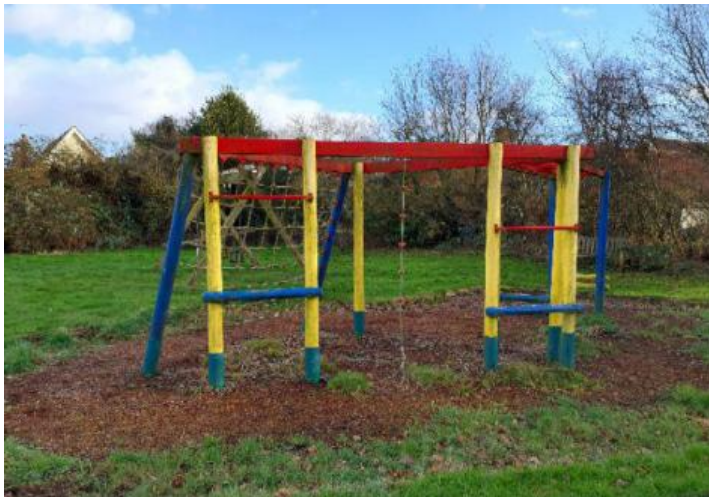
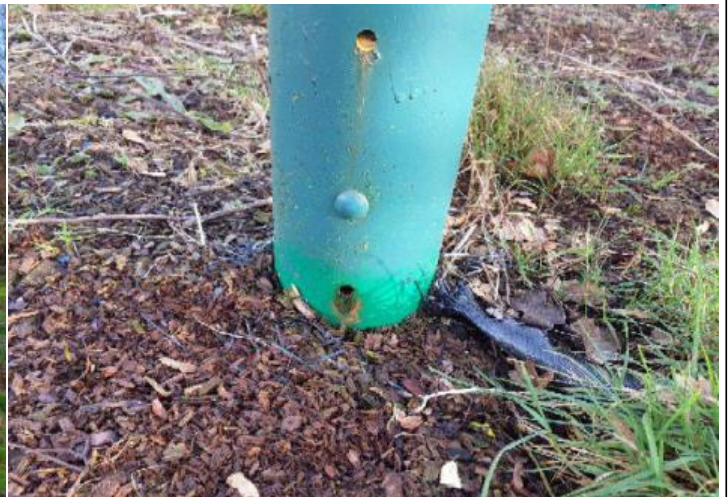
**Finding:** There is or are fixings missing on the item  
**Action:** Replace all missing fixings

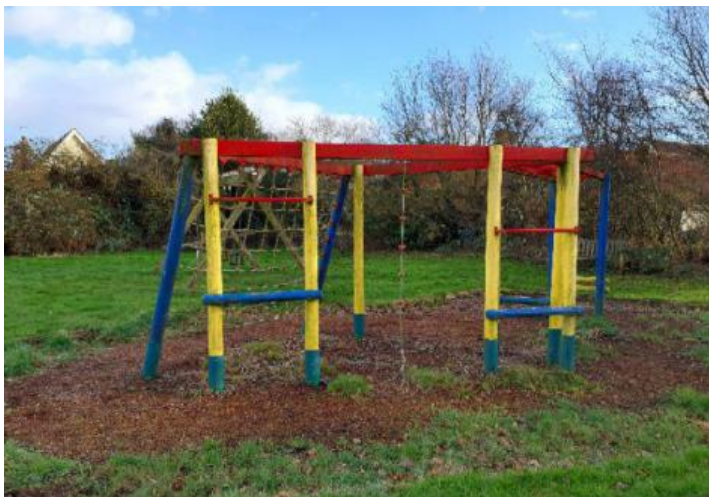
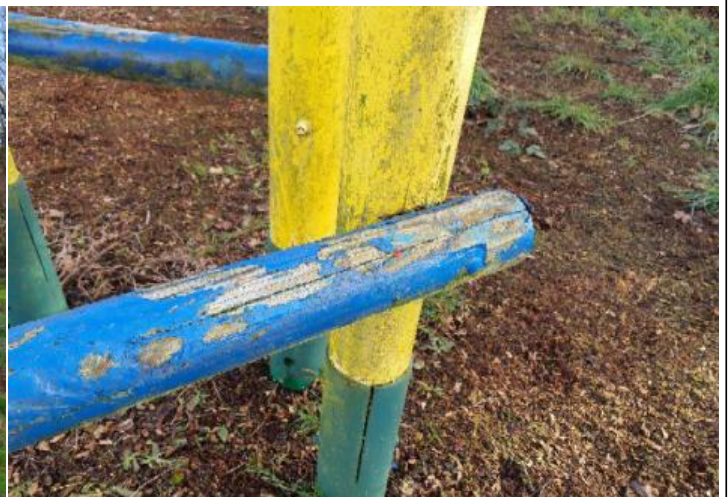
**Finding:** The timber stain is in poor condition

**Action:** Prepare all affected parts and re-stain with an appropriate preservative

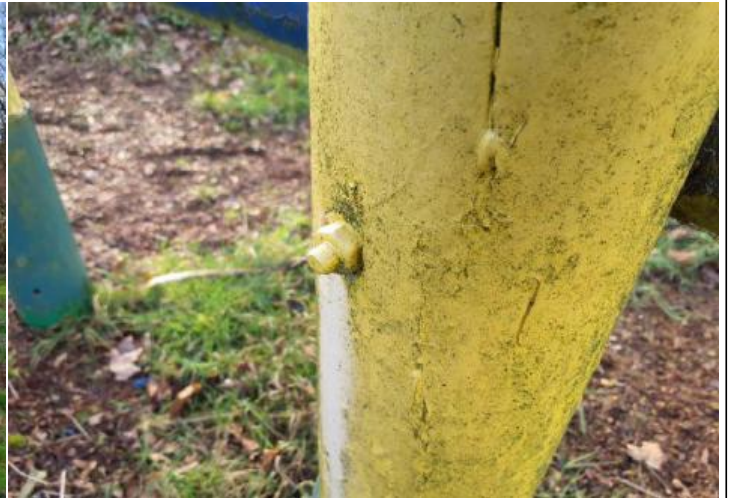
**Finding:** There are projecting bolt thread(s) present

**Action:** Remove excess thread length and deburr or provide cap

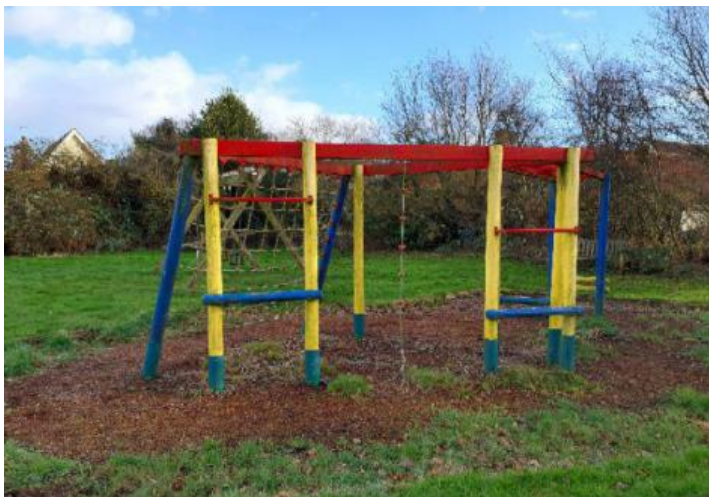
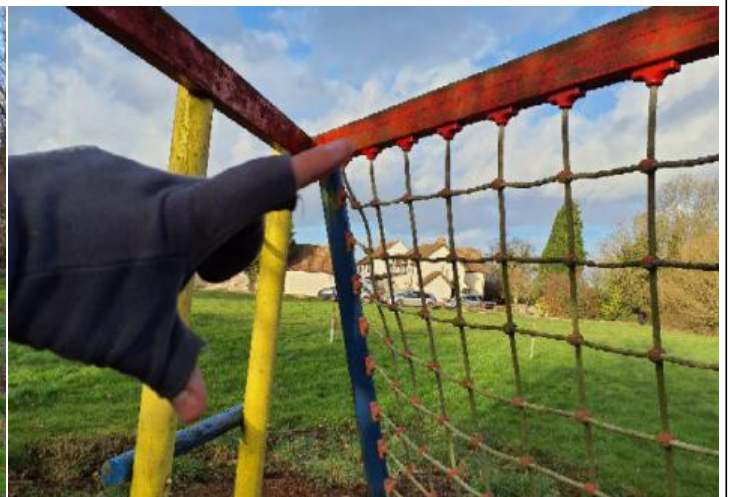
**Finding:** There are falls in excess of 600mm between adjacent components on the structure, in contravention of the recommendations set out in BS EN 1176 Part 1; 4.2.8.4

**Action:** Monitor - No remedial work recommended

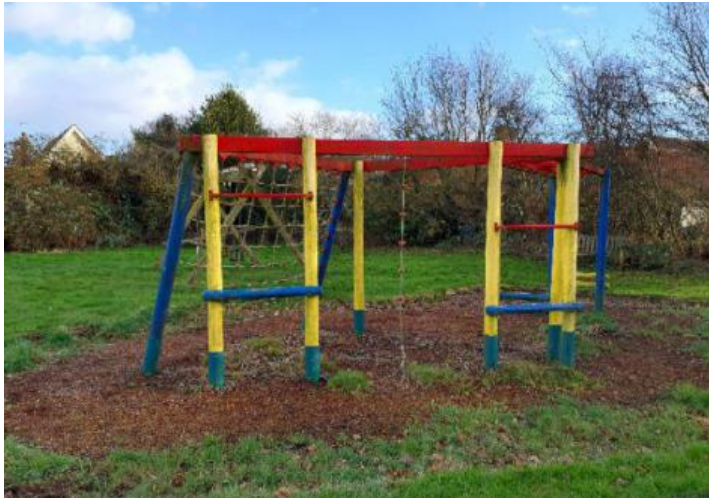
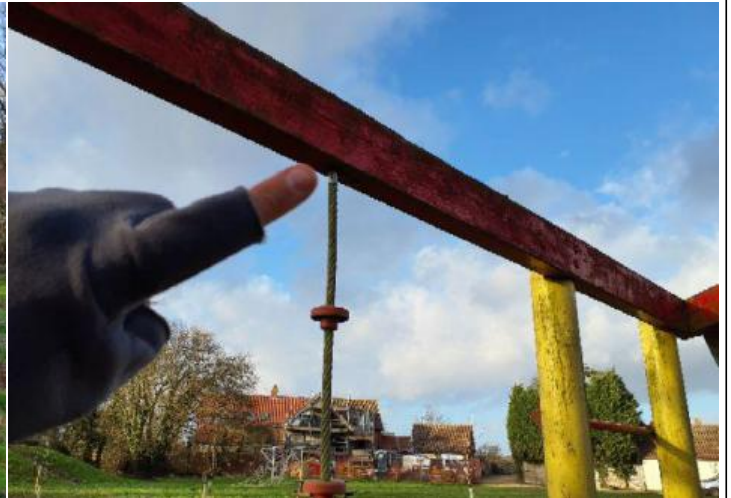
**Finding:** A number of fixing(s) have worked loose

**Action:** Secure all loose fixings

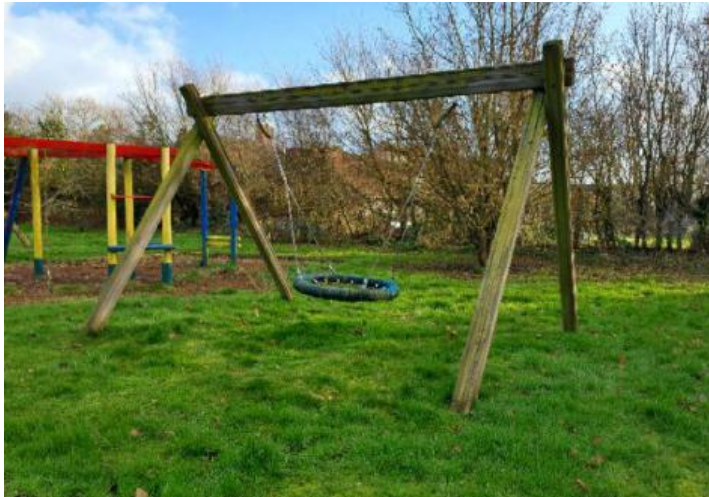
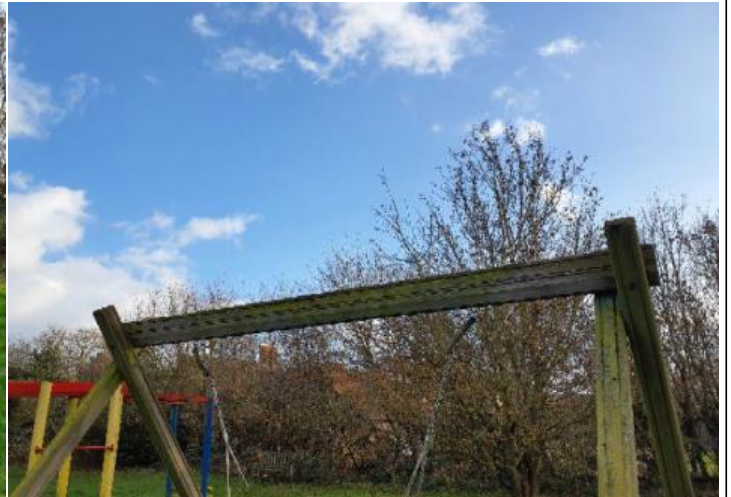
**Finding:** We do not recommend the installation of anti bird devices on equipment

**Action:** Remove and replace with upturned cable ties

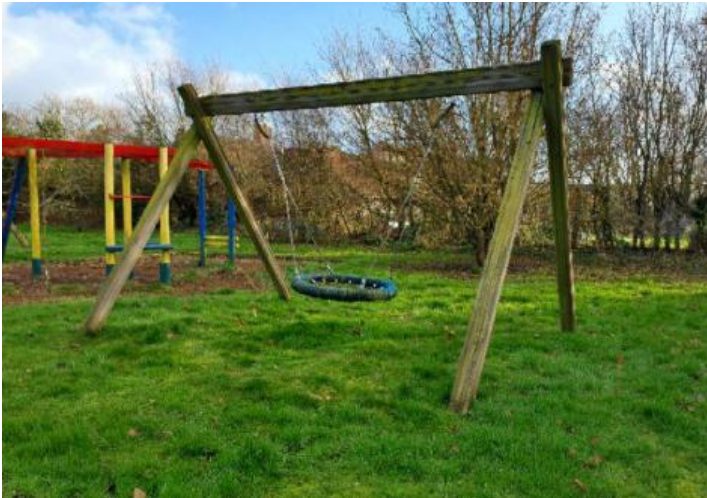
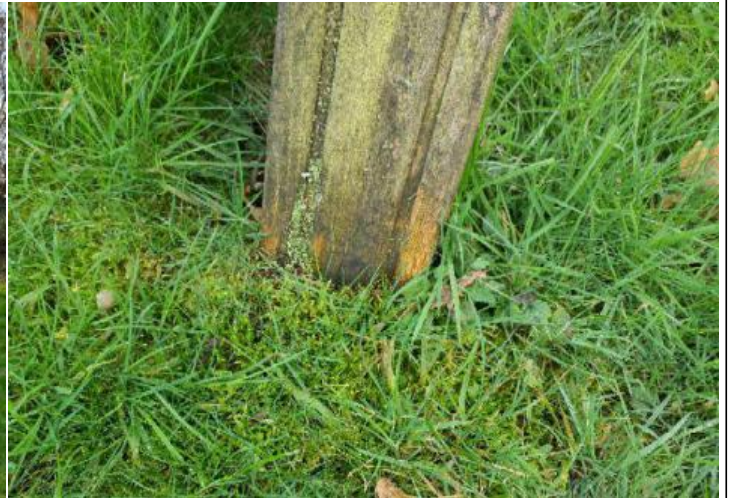
**Finding:** There is some strimmer / machinery damage apparent on the posts, this can penetrate the preservative applied to the timber and accelerate the rotting process

**Action:** Monitor for any deterioration (rot) and replace as required

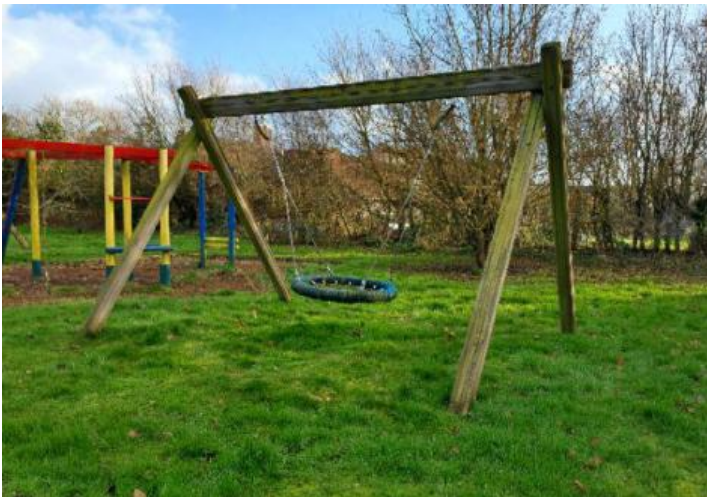
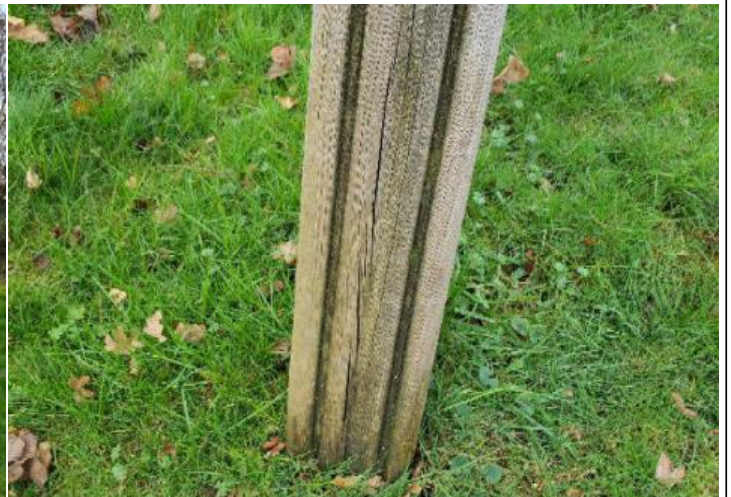
**Finding:** The timber has a number of splits/shakes or air cracks and this may affect the stability or allow water ingress which will accelerate the rotting process

**Action:** Monitor to ensure the splits do not cross through fixing points of the structure and/or cause any instability

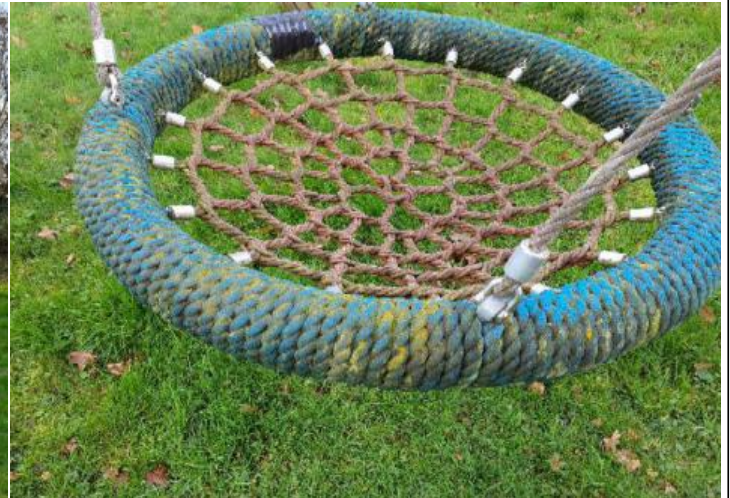
**Finding:** There is algae or moss on the surface of the equipment

**Action:** Clean and treat appropriately

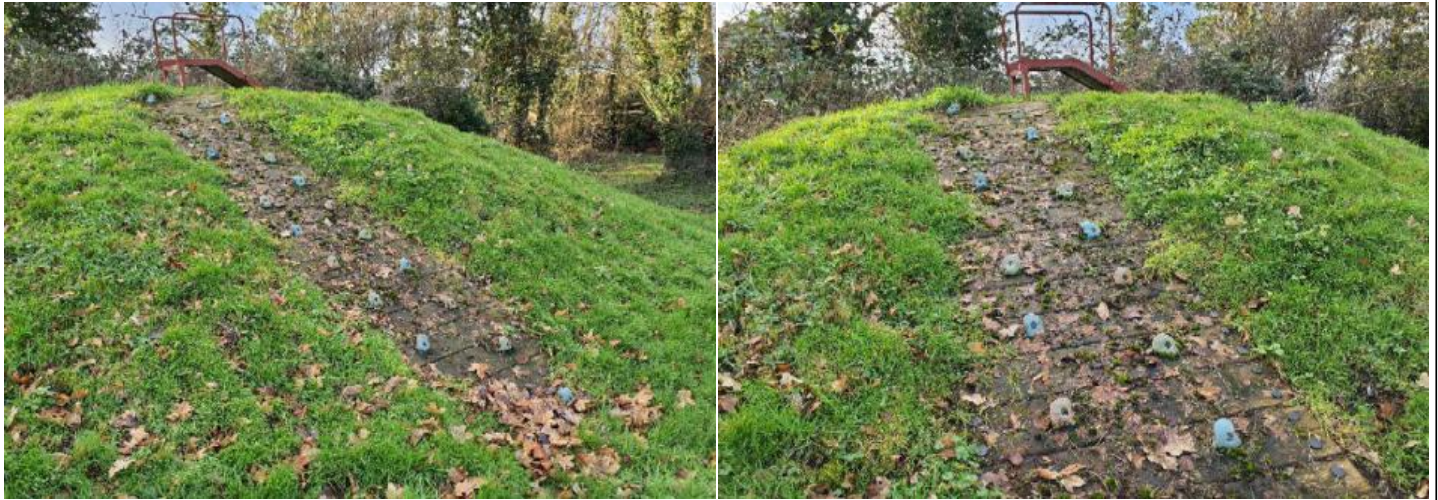
**Finding:** The adjacent surface has become overgrown

**Action:** Cut back and maintain

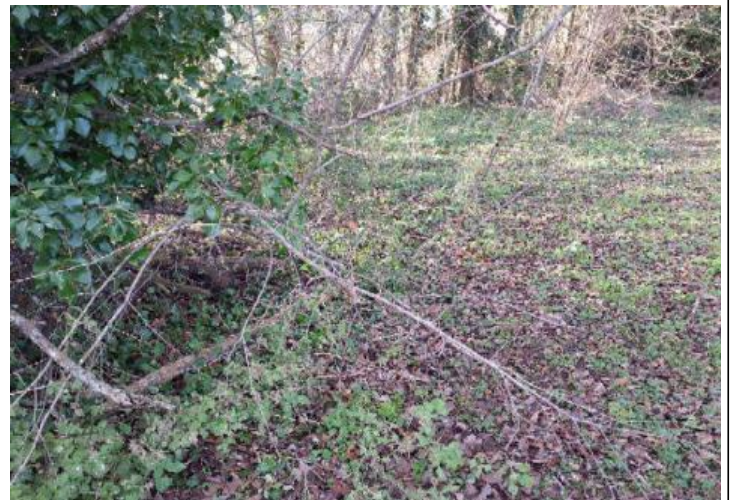
**Finding:** The overhanging branches form a hard object within the free space of the equipment in contravention of the requirements of BS EN 1176 Part 1

**Action:** Remove and cut back adjacent hedge

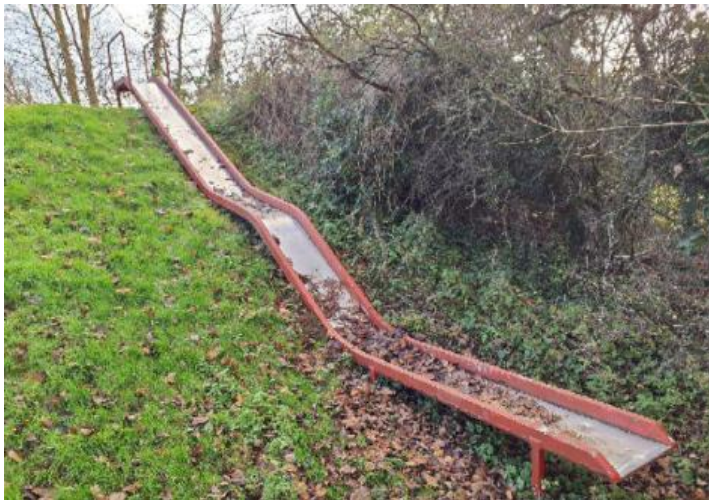
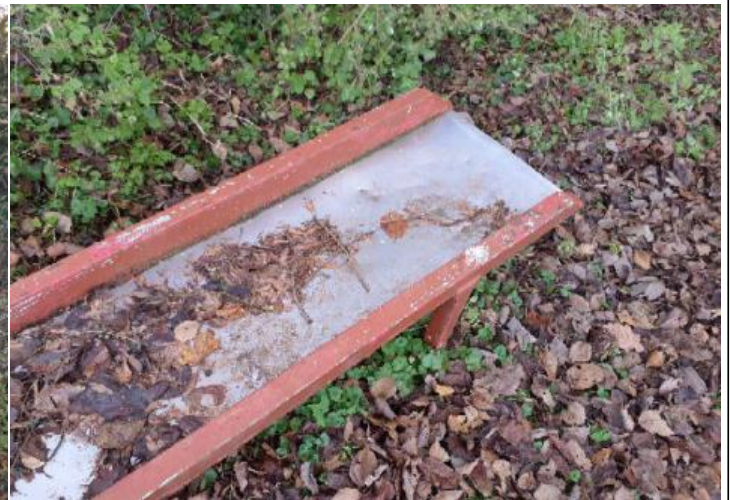
**Finding:** There are a number of dents in the slide surface  
**Action:** Monitor for any further deterioration and repair as required

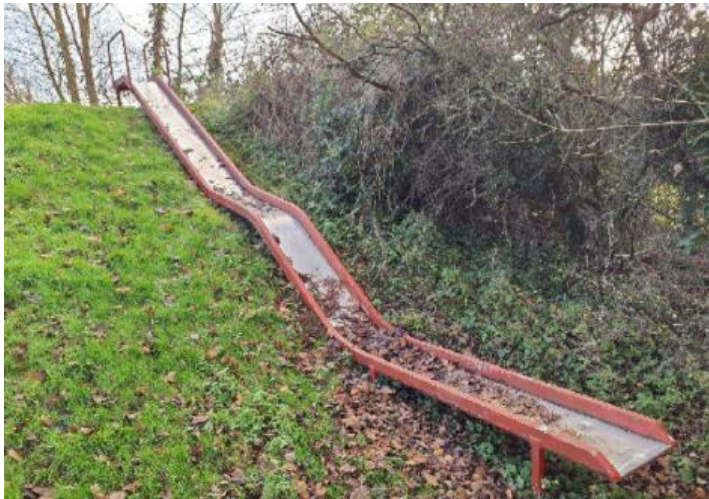
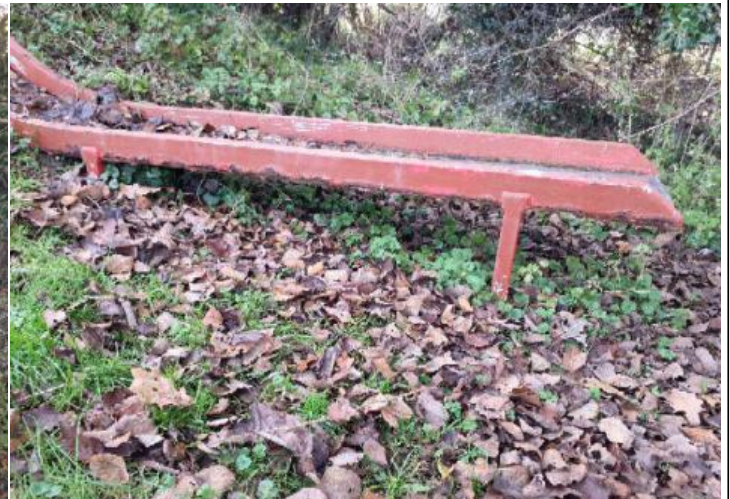
**Finding:** The slide run out section incline is not in the direction of travel and will hold water at the start of the runout; it should slope towards the direction of the exit  
**Action:** Monitor - No remedial work recommended
