# the **play inspection** company

## Annual Inspection

Mid Suffolk District Council

Creeting St Peter

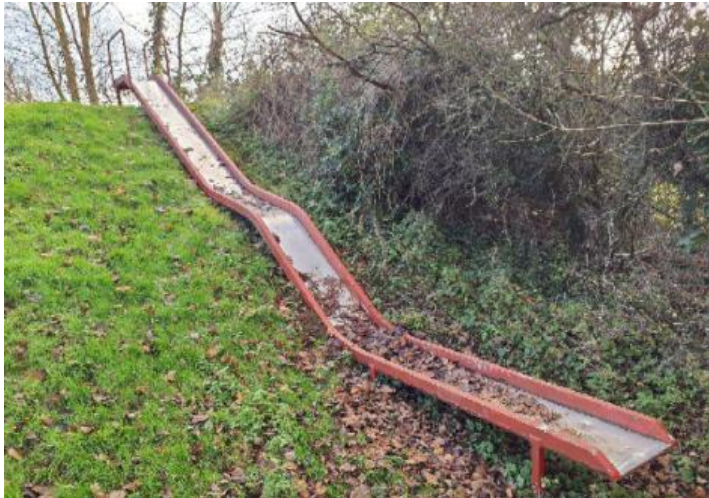
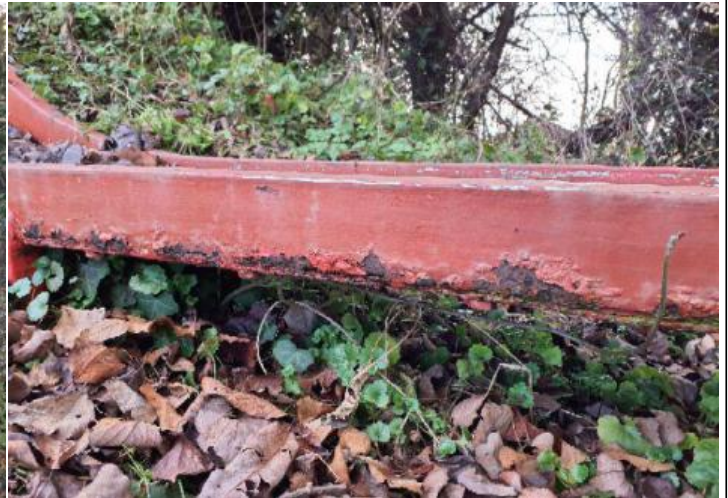
**Finding:** The paintwork on this item has been damaged or worn exposing the metal underneath which is rusting / corroding

**Action:** Treat affected areas and repaint

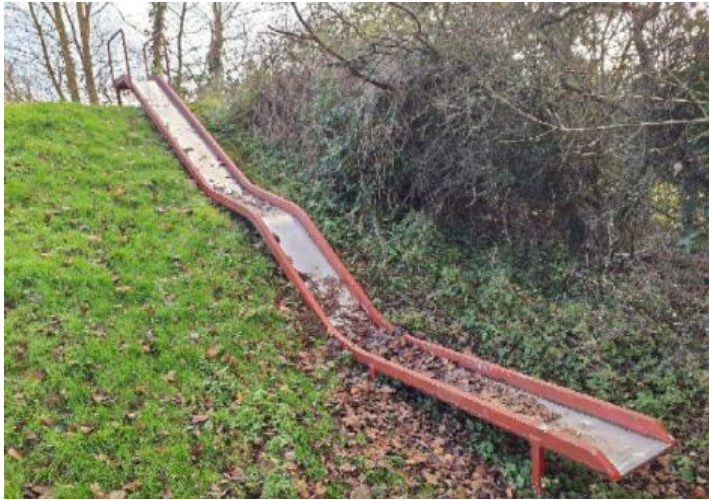
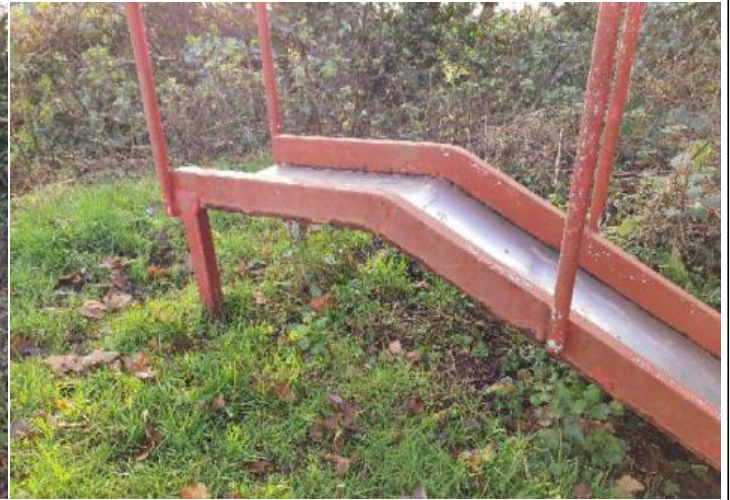
**Finding:** The slide start section incline is not in the direction of travel; it should slope towards the direction of the sliding surface to meet the requirements of BS EN 1176 Part 3

**Action:** Monitor - No remedial work recommended

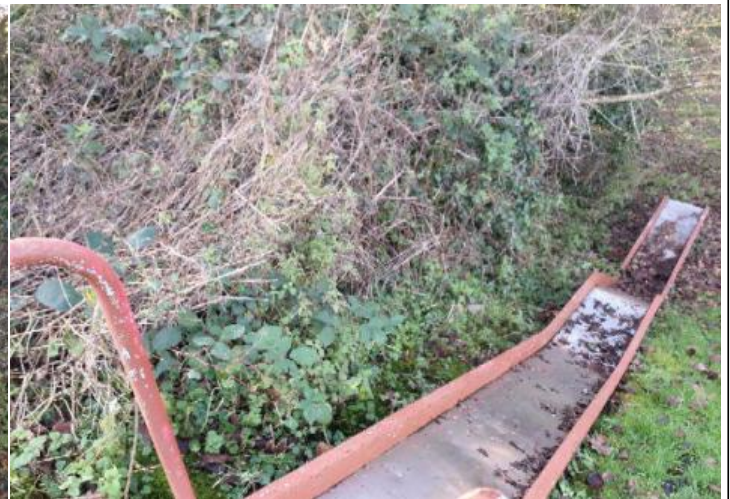
**Finding:** The adjacent hedge forms a hard object within the free space of the equipment in contravention of the requirements of BS EN 1176 Part 1

**Action:** Cut back and maintain

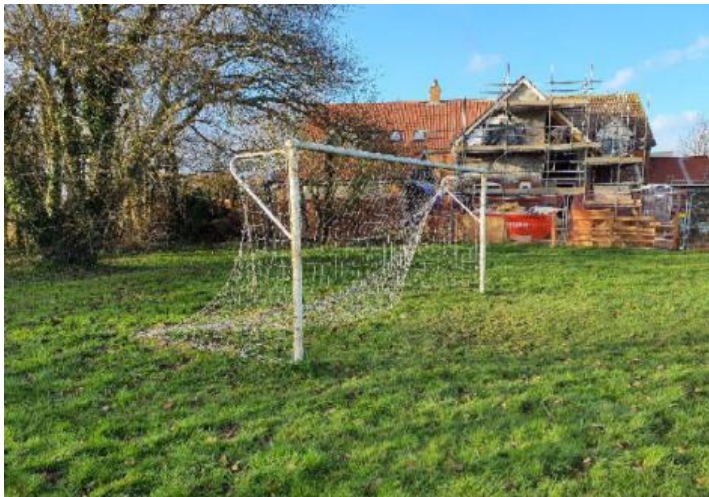
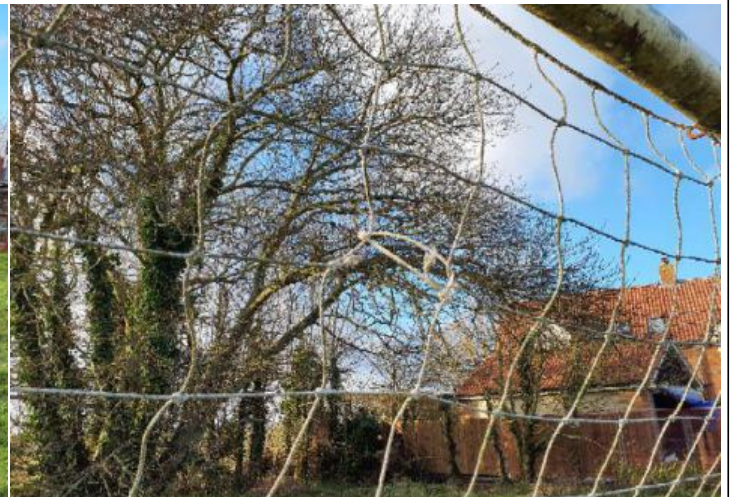
**Finding:** The net is damaged

**Action:** Replace

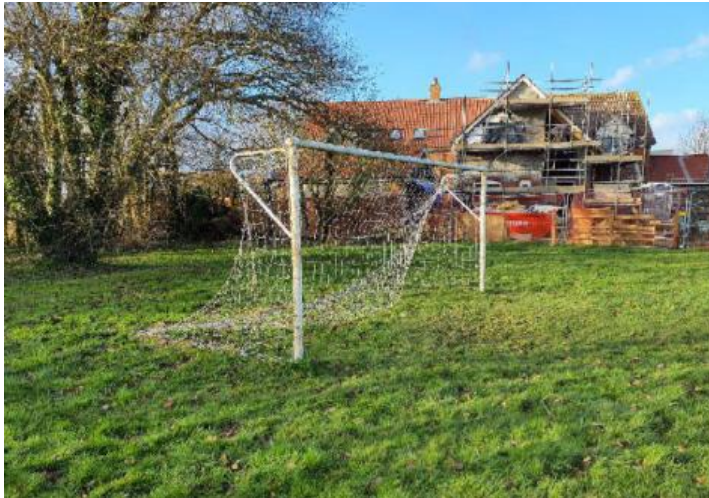
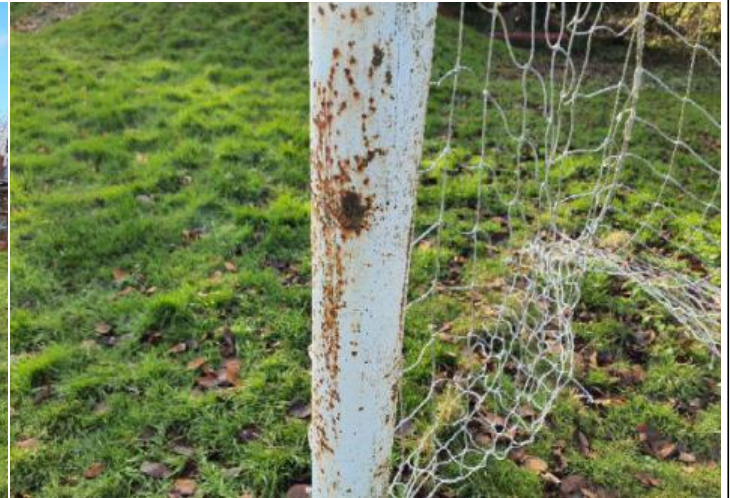
**Finding:** The paintwork on this item has been damaged or worn exposing the metal underneath which is rusting / corroding

**Action:** Treat affected areas and repaint
