## **Response to queries raised by Andy Aylott (AA) at the Gateway 14 Stakeholder Meeting 28/02/24.**

AA comments are in bold and italics, with Gateway 14 responses below.

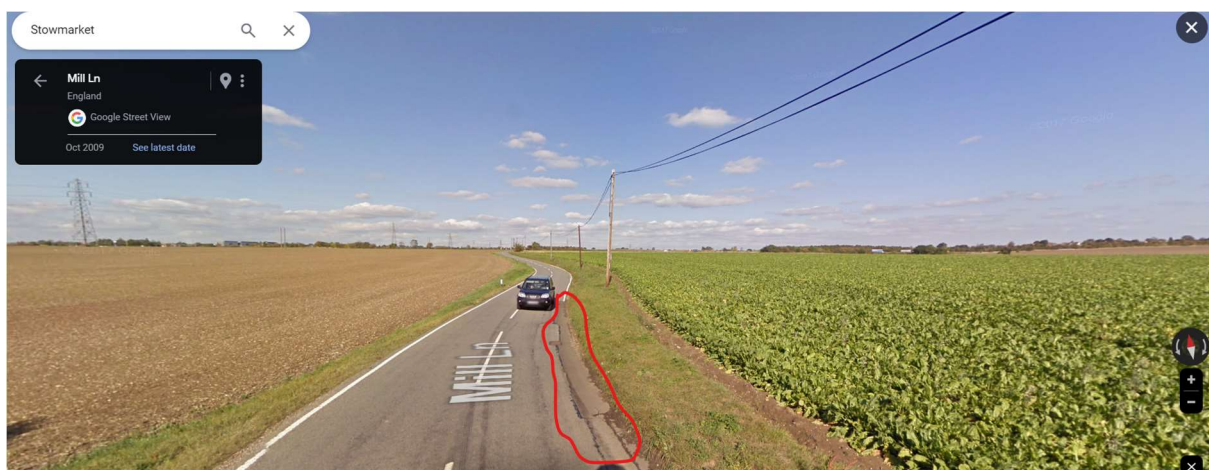
This is a long-standing issue with SCC Highway owned land, evidenced by the photographs below. Damage to the same area was evident well before Gateway 14 commenced.

Image below from 2009 where you can clearly see the area has been 'patched'.

Gateway 14 has raised the condition of this road with the highways department as an issue. It would be helpful for residents to also raise this as a concern directly with SCC Highways department.

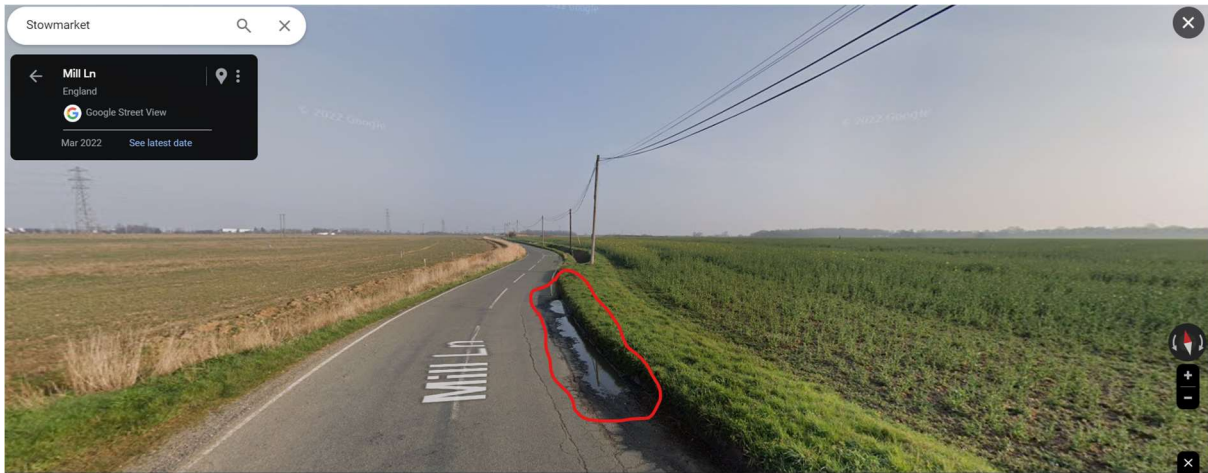
Image below from 2022, prior to the development, where the same damage can be seen.

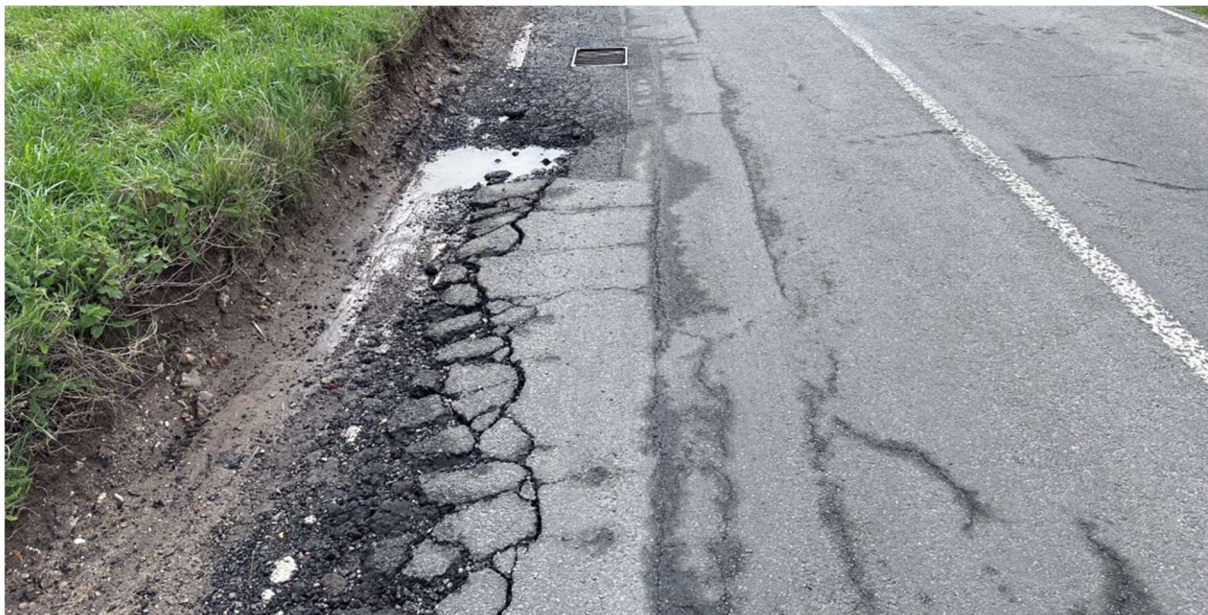
Image below of the same area taken 28 Feb 2024

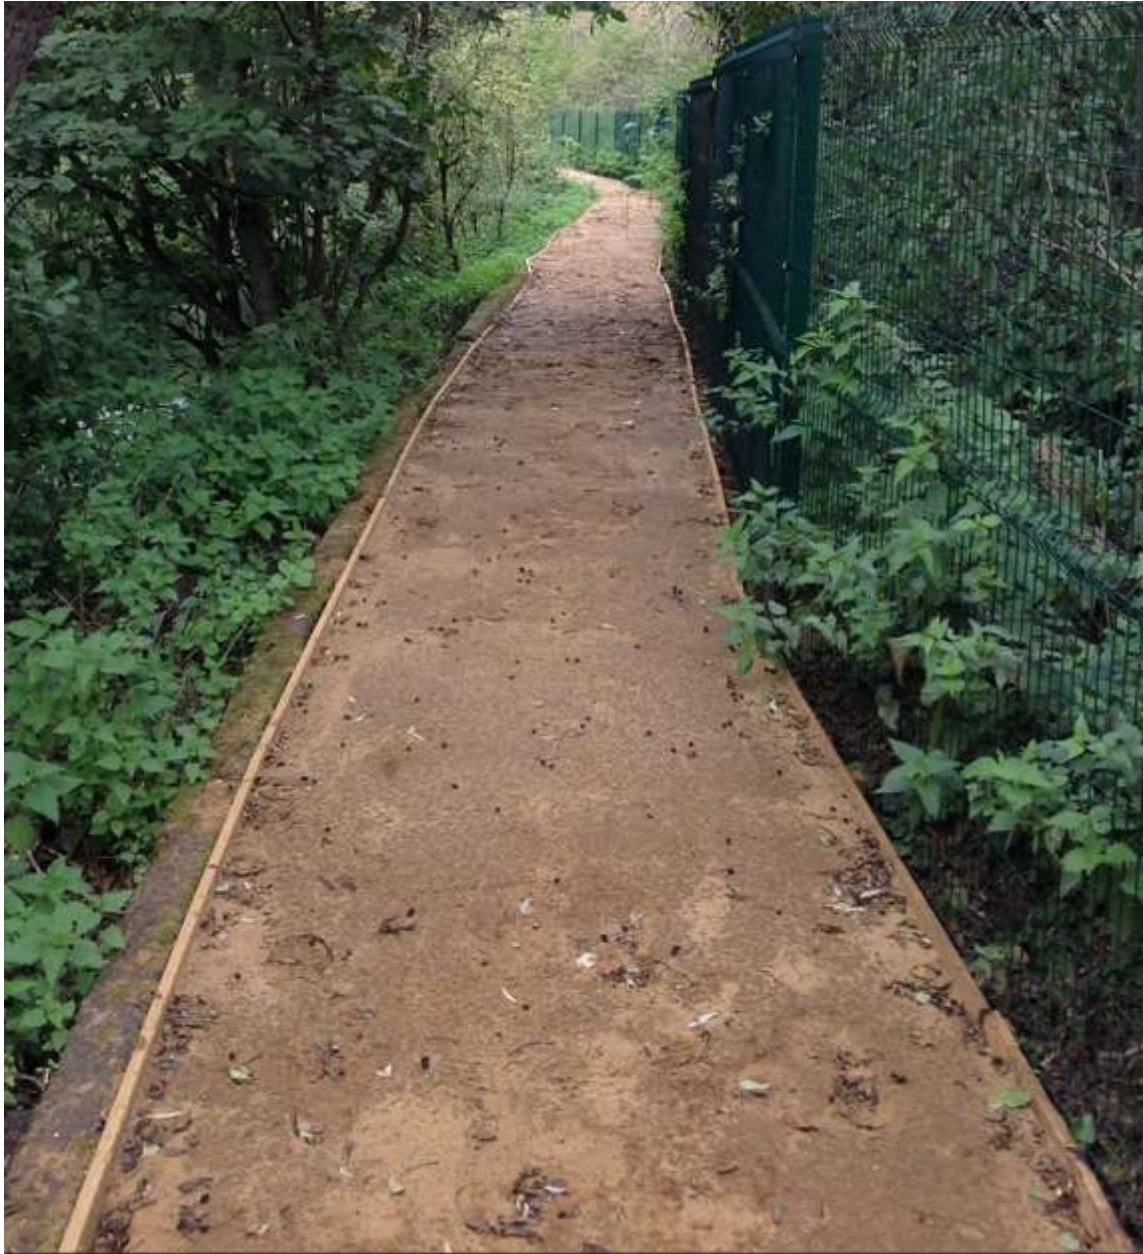
- The image below of the new Hoggin path laid along Muntons River Gipping Path. This was undertaken in May 2022 and is a good example of how the path performs over time.

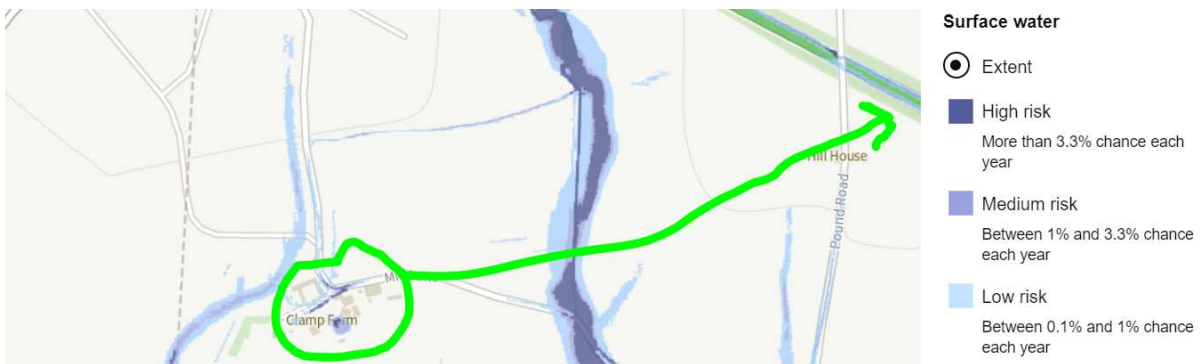
- *Surface water flood risk*

It is also important to review the national flood risk assessment which highlights areas at risk of flooding. The data available highlights the area on the bend as a ‘high risk’ for Surface Water flooding. In periods of heavy rain, surface water is always going to find its way to the areas of dark blue.

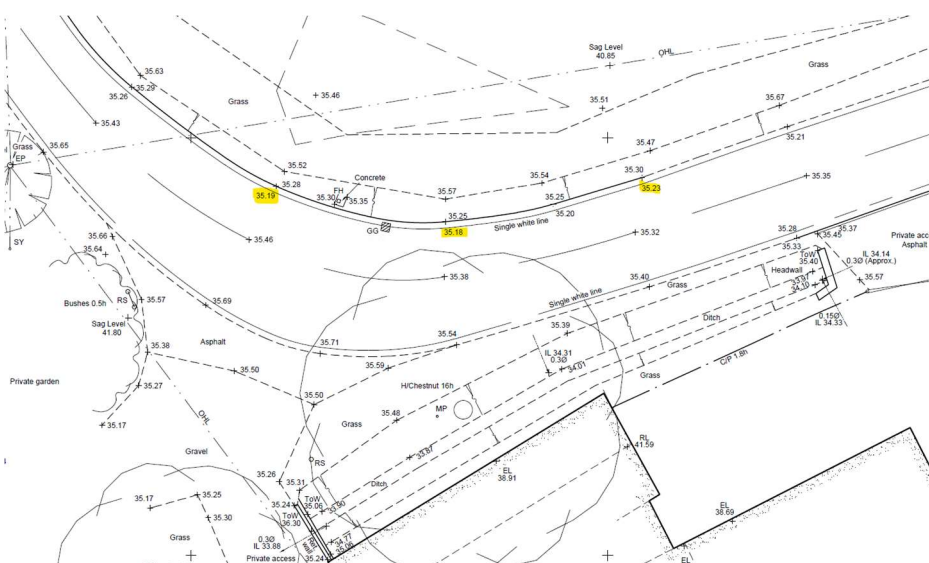
- *Low points*

This area is the lowest point of the land so surface water from farmland, existing roads and undeveloped plot areas within the vicinity will inevitably find its way here during periods of torrential downfall.

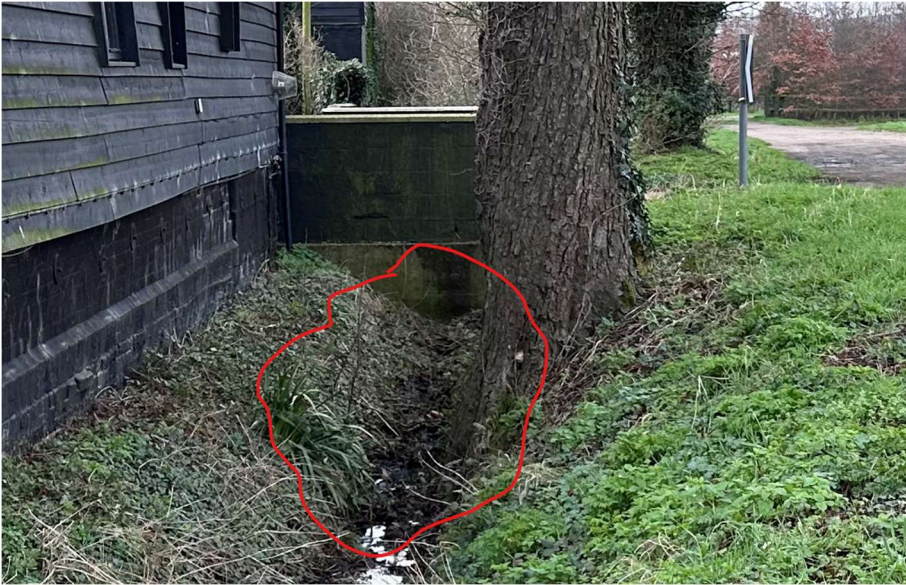
From our survey on Wednesday 28 February 2024, the ditch opposite the bend looks like it's never been maintained and is clearly silted up with leaves and debris. The section adjacent to the retaining wall looks completely blocked and impassable for water.

- ditch blocked

Is there a regular maintenance regime for this ditch and if so, what is the regularity of the maintenance? How many times has this been cleaned out? Subject to residents' title investigations have you approached Mex Homes or the other residents with responsibilities?

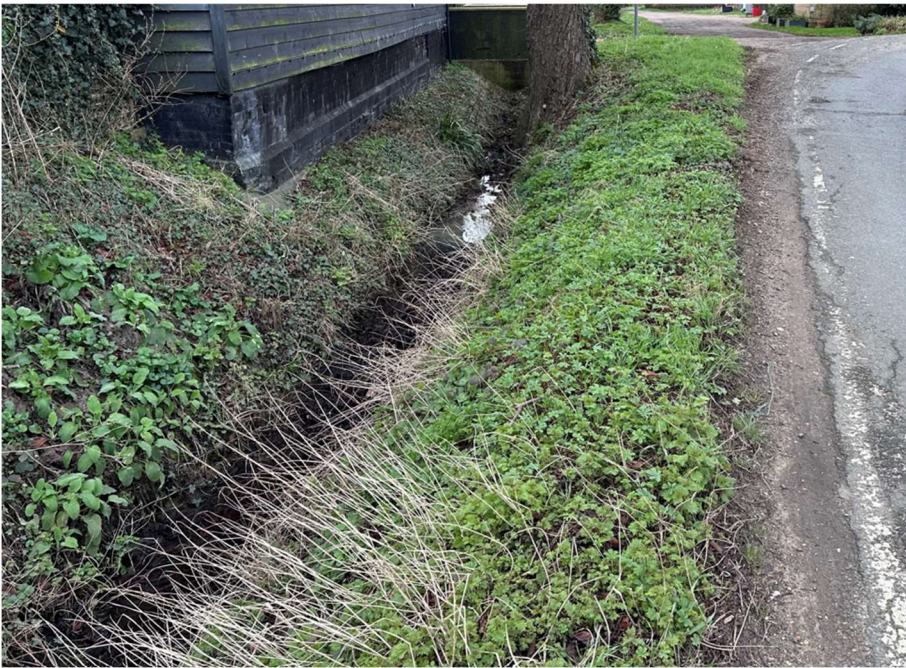
- ditch blocked

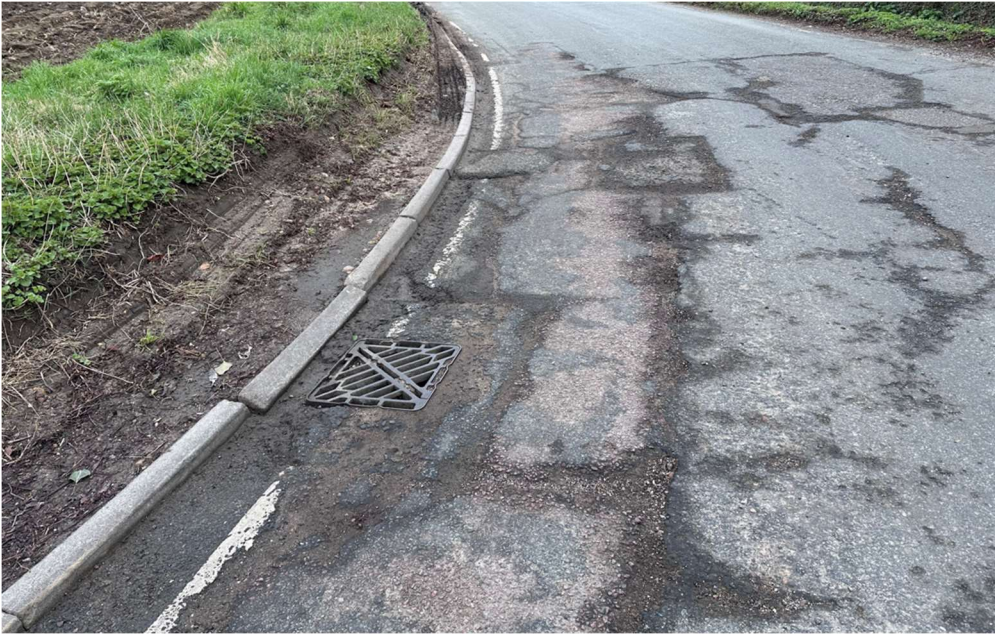
The other major factor is the poor quality of road and surface water drainage. It's clear the gullies are damaged and blocked as they are not controlling water which bypassed the underground systems and runs over the road finding its way to the lowest point – which is the ditch but that is blocked!

- damage

Gateway 14 has raised this issue with SCC highways, but it would be helpful if residents could also address this directly with SCC Highways.

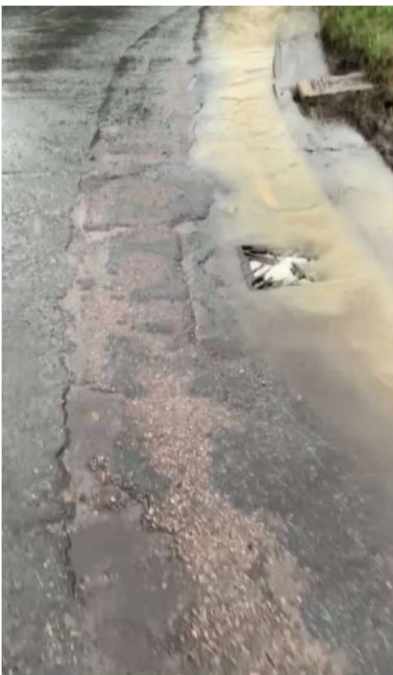
- gulley blocked / not working

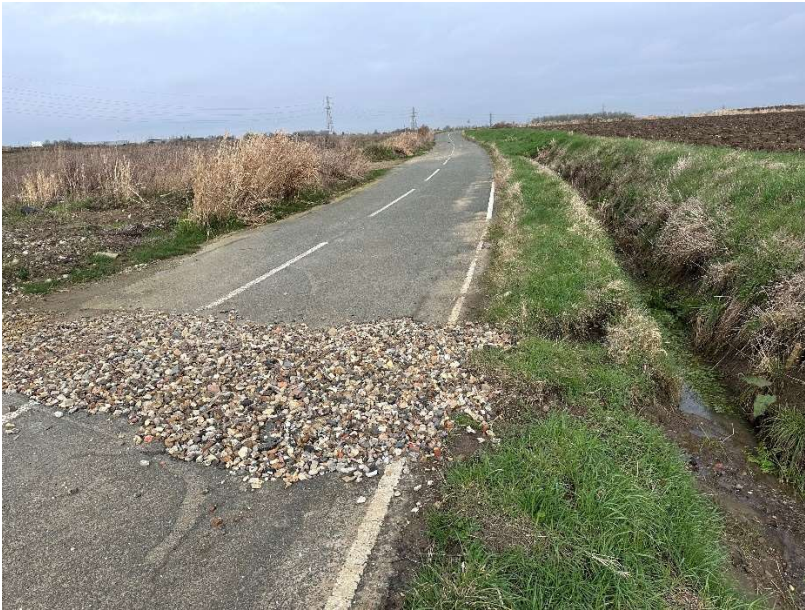
- Land drain on mill lane

Since the additional land drains were installed during October and November 2023, the surface water run off has improved and water finds its way into the irrigation ditch as planned.
