# the **play inspection** company

## Annual Inspection

Mid Suffolk District Council

Creeting St Peter

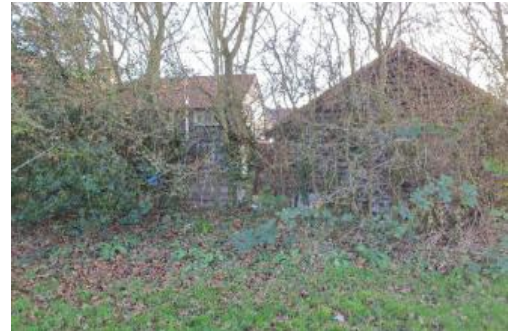
**Item:** Hedge  
**Manufacturer:** Natural Feature  
**Surface Type:** N/A  
**Item Quantity:** 1  
**Equipment Compliance:** N/A  
**Surface Area Compliance:** N/A

This item is satisfactory - no work required -

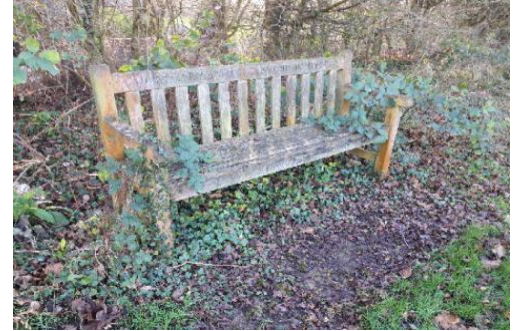
**Item:** Bench  
**Manufacturer:** Not Identified  
**Surface Type:** Grass  
**Item Quantity:** 1  
**Equipment Compliance:** N/A  
**Surface Area Compliance:** N/A

There is some evidence of rot in the timber - Monitor for any further deterioration and replace as required

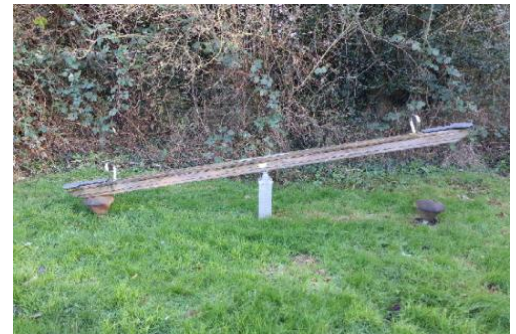
**Item:** See Saw  
**Manufacturer:** Fenland Leisure Products  
**Surface Type:** Grass Matrix Tiles  
**Item Quantity:** 1  
**Equipment Compliance:** Yes  
**Surface Area Compliance:** Yes

There is minor lateral movement of the beam - Monitor for any further deterioration and repair or replace as required

The timber has a number of splits/shakes or air cracks and this may affect the stability or allow water ingress which will accelerate the rotting process - Monitor to ensure the splits do not cross through fixing points of the structure and/or cause any instability

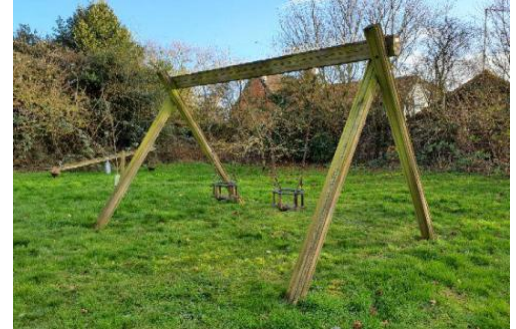
**Item:** 1 Bay 2 Seat (Cradle)  
**Manufacturer:** Fenland Leisure Products  
**Surface Type:** Grass Matrix Tiles  
**Item Quantity:** 1  
**Equipment Compliance:** Yes  
**Surface Area Compliance:** Yes

We do not recommend the installation of anti bird devices on equipment - Remove and replace with upturned cable ties

The chains are rusting - Monitor for any further deterioration and replace as required

This design of swing joint has been known to fail on the weld connecting the joint to the threaded stud - We would recommend that the joint be dismantled and checked on a regular basis or consulting with manufacturer on whether a Secondary Safety Device can be fitted

There is some strimmer / machinery damage apparent on the posts, this can penetrate the preservative applied to the timber and accelerate the rotting process - Monitor for any deterioration (rot) and replace as required

There is some evidence of rot in the timber - Monitor for any further deterioration and replace as required

There is some notable evidence of chain wear - Monitor for any further deterioration and replace when 40% worn

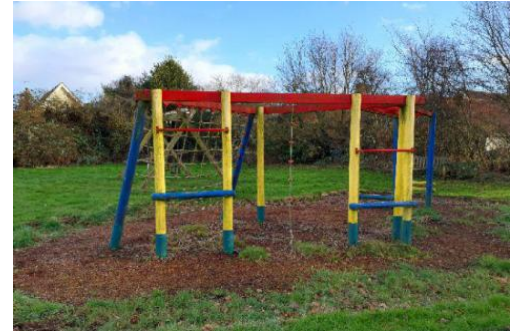
**Item:** Multi Play (Junior)  
**Manufacturer:** Not Identified  
**Surface Type:** Bark Mulch  
**Item Quantity:** 1  
**Equipment Compliance:** No  
**Surface Area Compliance:** Yes

The depth of the loose fill surfacing is lower than the recommended depth specified in BS EN 1176; the free height of fall of the equipment is less than 2.0m and a minimum of 300mm depth should be provided (including an extra 100mm to allow for compaction and displacement as per BS EN 1176 Part 1 - Table 4) - Top up loose fill surfacing to recommended levels

There are areas or parts of the timber edging that have rotted or are damaged - Replace all affected timbers

There is/are finger entrapment/s in the post due to missing inserts and the item fails to meet the requirements of BS EN 1176 Part 1 4.2.7.6 Entrapment of fingers - Provide inserts to remove entrapment

There is or are fixings missing on the item - Replace all missing fixings

The timber stain is in poor condition - Prepare all affected parts and re-stain with an appropriate preservative

There are falls in excess of 600mm between adjacent components on the structure, in contravention of the recommendations set out in BS EN 1176 Part 1; 4.2.8.4 - Monitor - No remedial work recommended

A number of fixing(s) have worked loose - Secure all loose fixings

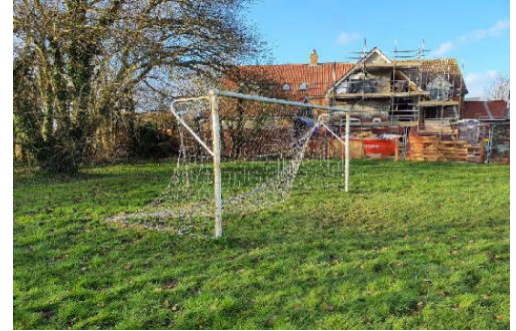
**Item:** Football Goal  
**Manufacturer:** Not Identified  
**Surface Type:** Grass  
**Item Quantity:** 1  
**Equipment Compliance:** N/A  
**Surface Area Compliance:** N/A

NB: We have undertaken a maintenance inspection only of the football goal(s); full load testing falls outside the scope of our inspection. - Implement load testing as required

The net is damaged - Replace

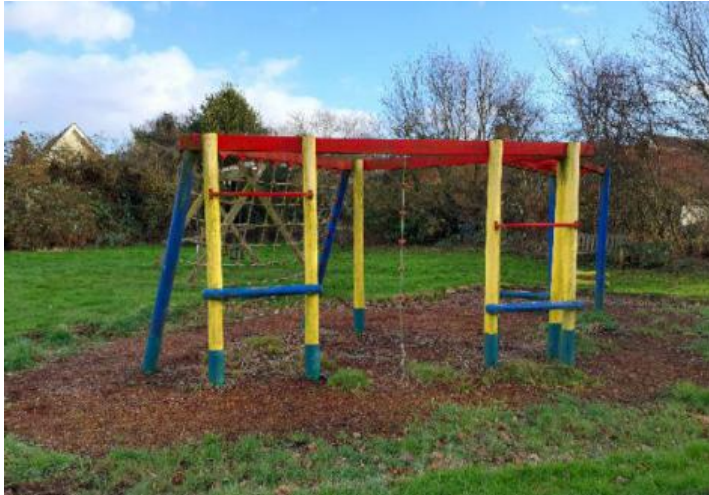
**Item:** Activity Equipment - Multi Play (Junior)  
**Manufacturer:** Not Identified

**Finding:** There are projecting nail ends present

**Action:** Remove and provide more appropriate fixings if required

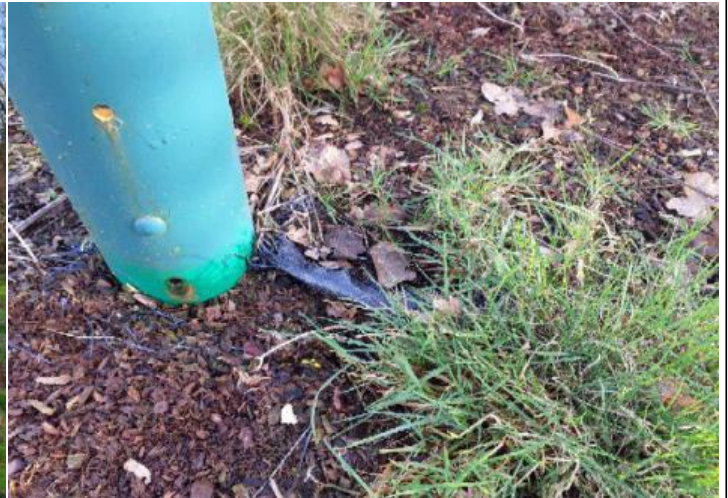
**Item:** Activity Equipment - Multi Play (Junior)  
**Manufacturer:** Not Identified

**Finding:** The safety surface is low and the membrane is exposed creating trip points

**Action:** Remove or resecure the exposed membrane and top up the surface to the correct level

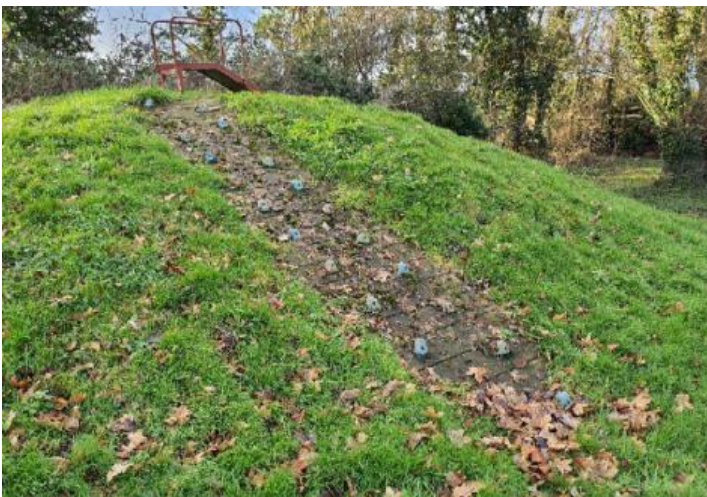
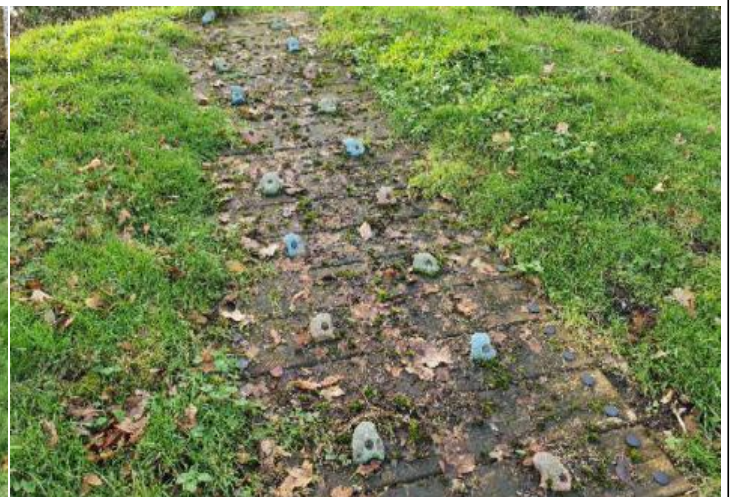
**Item:** Activity Equipment - Climbing Wall  
**Manufacturer:** Not Identified

**Finding:** There is algae or moss on the surface of the equipment

**Action:** Clean and treat appropriately

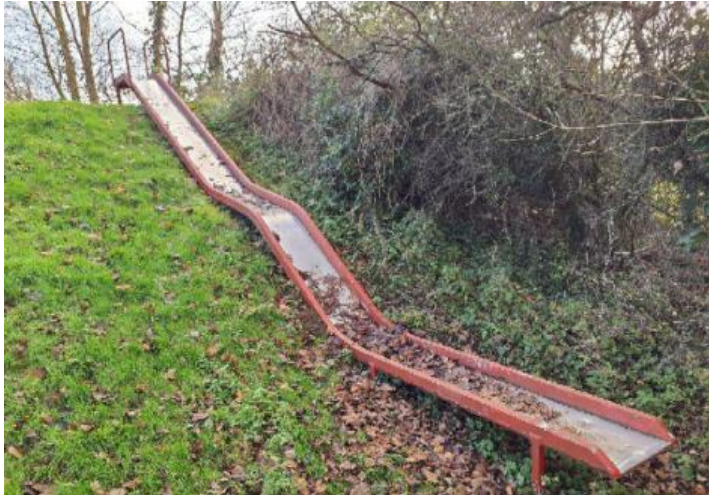
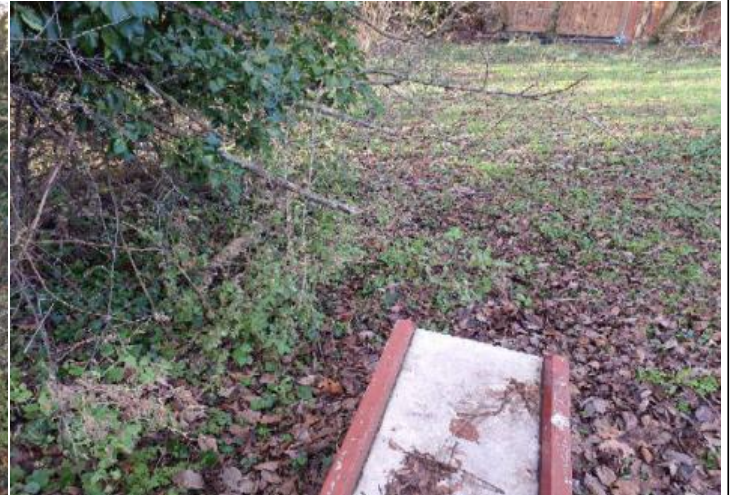
**Item:** Other - Embankment Slide  
**Manufacturer:** Not Identified

**Finding:** The overhanging branches form a hard object within the free space of the equipment in contravention of the requirements of BS EN 1176 Part 1

**Action:** Remove and cut back adjacent hedge

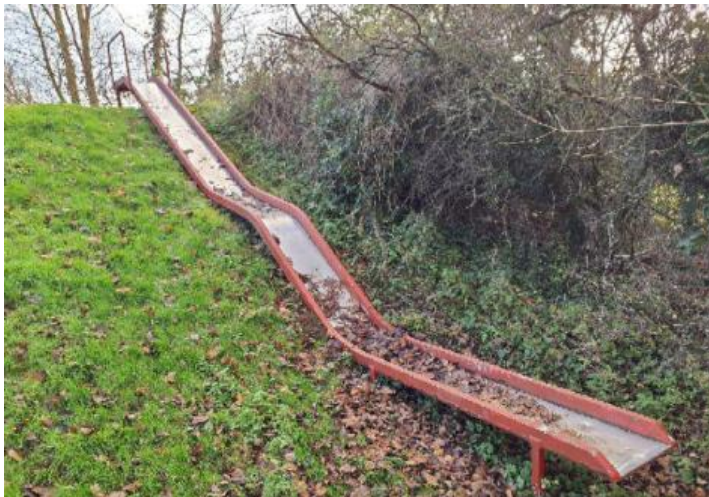
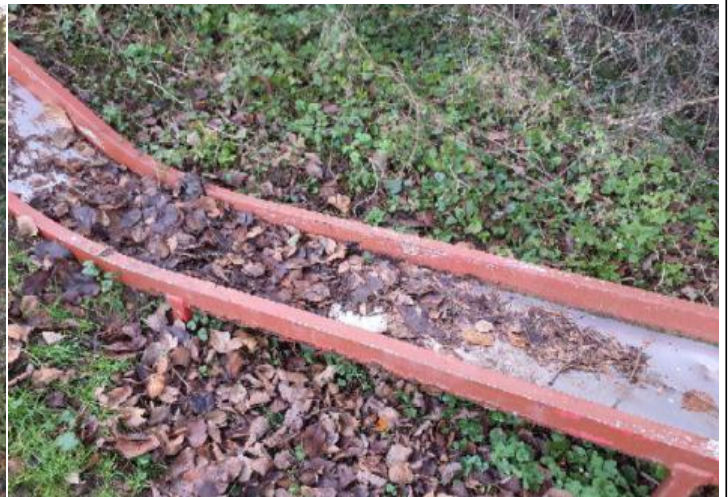
**Item:** Other - Embankment Slide  
**Manufacturer:** Not Identified

**Finding:** There is some tree debris on the equipment

**Action:** Remove and maintain

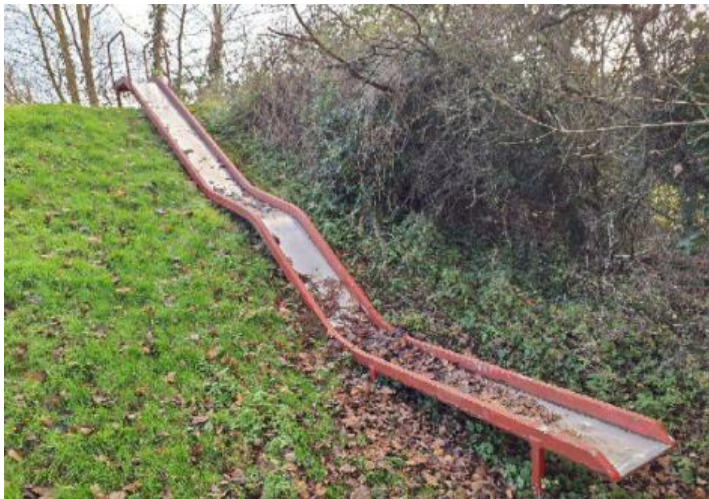
**Item:** Other - Embankment Slide  
**Manufacturer:** Not Identified

**Finding:** The adjacent hedge forms a hard object within the free space of the equipment in contravention of the requirements of BS EN 1176 Part 1

**Action:** Cut back and maintain
