## **Response to queries raised by Andy Aylott (AA) at the Gateway 14 Stakeholder Meeting 28/02/24.**

AA comments are in bold and italics, with Gateway 14 responses below.

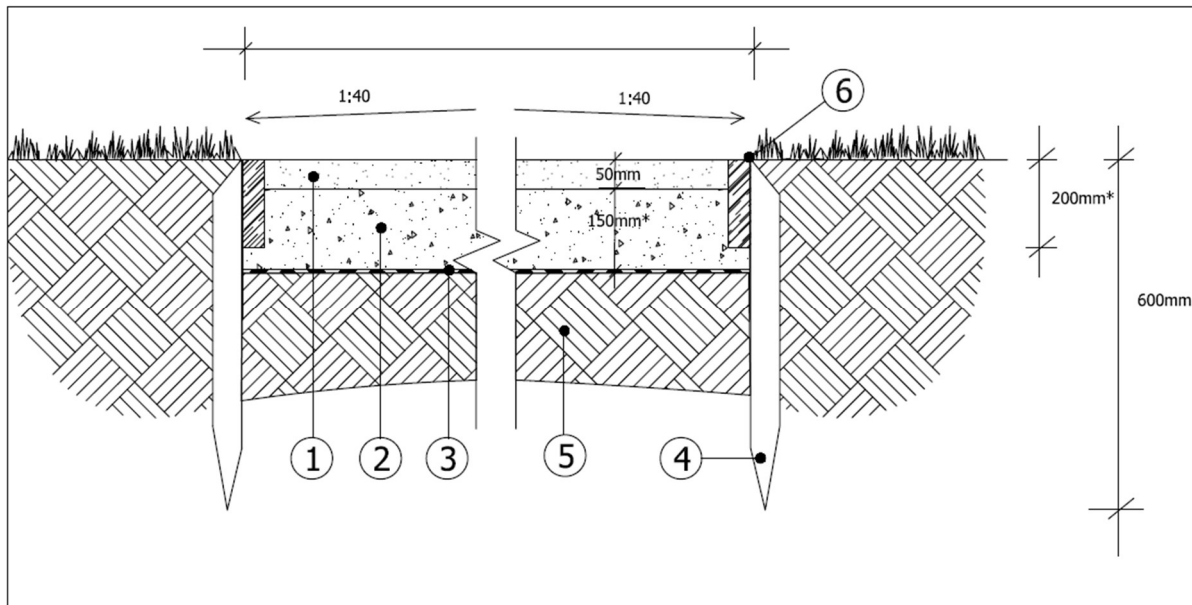
The paths are made from a traditional Hoggin build up not just sand, as per the detail below. It is a mixture of gravel, sand and clay on a bed of hardcore.

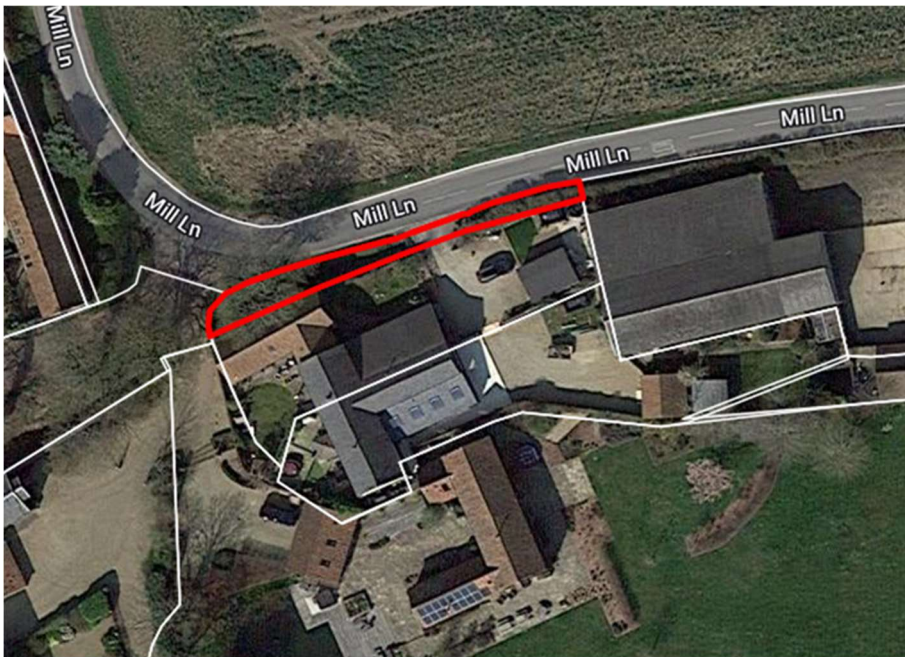
We are aware Mex Homes Ltd owns the absolute freehold title of this strip land including the ditch and access road. Shown red below for clarity. There may be responsibilities within the titles of the adjacent properties with regard to the maintenance of this ditch- it would be helpful if residents could check their title documents.

- area owned by Mex

Homes Ltd
